SERVICE PROCEDURE

G-07501 April 2007

SUBJECT: SAFETY RECALL (U.S., EXPORT)

BATTERY CABLES on certain 9000 Models built 4/1/2002 thru 12/25/2006 with Caterpillar® Engines

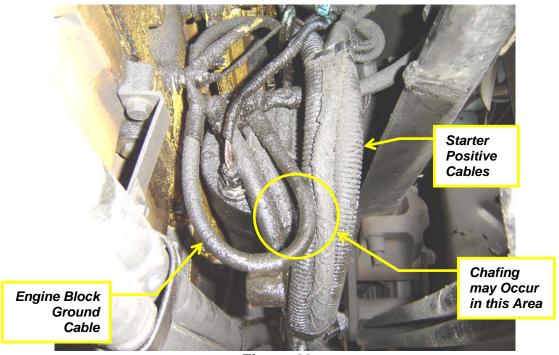
Figure 29 -Chafing may occur between Engine Block Ground and Newly Located
Positive cables.

TO PREVENT CHAFING OF THE **POSITIVE** CABLES AGAINST THE **ENGINE** BLOCK GROUND CABLE (SEE FIGURE 29), PLEASE ENSURE **ENGINE** BLOCK GROUND CABLE IS CLOCKED IN THE DOWNWARD (6 O'CLOCK) POSITION, SEE FIGURE 30.

• If contact or chafing of the ENGINE GROUND cable against the Battery Cables is present, rotate and tighten the ground cable on the starter terminal so it is straight down (6 o'clock position) and not contacting the starter positive cables, see figure 30.

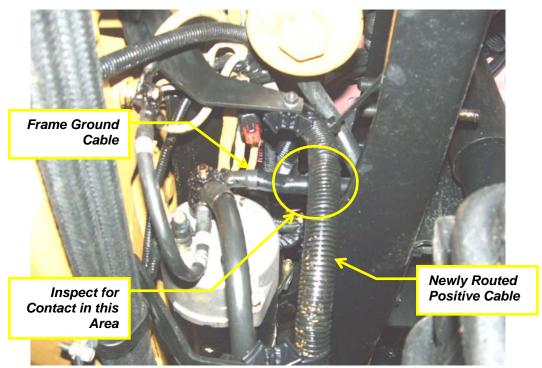
Figure 31 - FRAME Ground Inspection

TO PREVENT CHAFING OF THE **POSITIVE** CABLES AGAINST THE **FRAME** GROUND CABLE (SEE FIGURE 31), PLEASE ENSURE **FRAME** GROUND CABLE IS NOT IN CONTACT WITH THE NEWLY ROUTED POSITIVE CABLES, SEE **FIGURE 32**.

• Ensure cables are not in contact.
