MIL On with DTC P3400 and/or P3497? Try This Quick Test First

Currently Applies To: '08–12 Accord V6 with A/T, '10–12 Crosstour, '08–10 Odyssey (Touring and EX-L), '11–12 Odyssey, and '09–12 Pilot

HONDA
ServiceNews

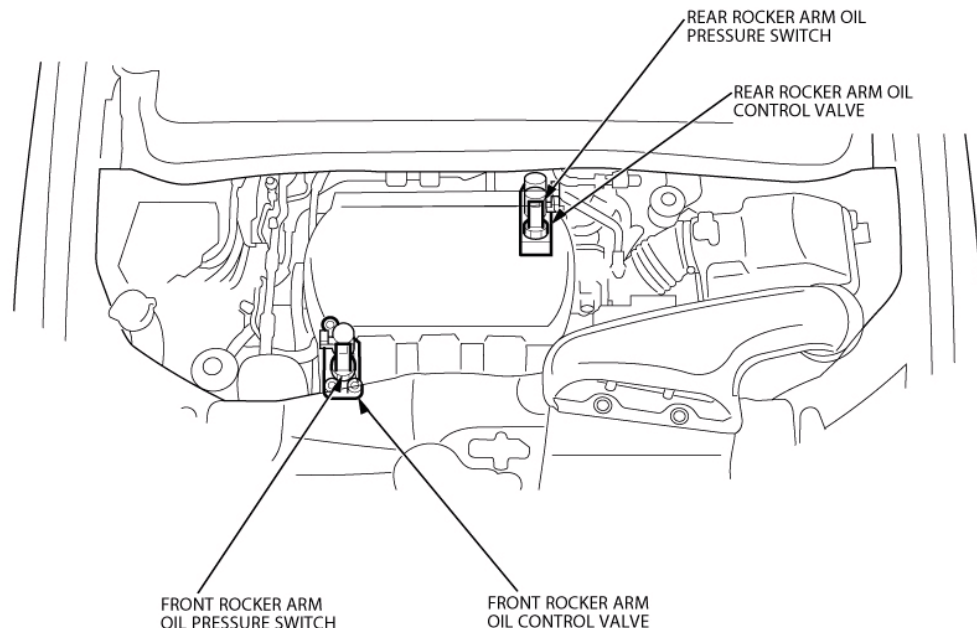
1. Check the engine oil level. Low oil pressure can set these DTCs.
 - If the oil level is low, adjust it or replace the oil if needed. Then, follow the procedure in S/B 11-033, *Engine Oil Consumption; MIL May Be On With DTC P3400 and/or P3497*.
 - If the oil level is OK, go to step 2.
2. Clear the DTC(s), and turn the ignition switch to ON (II) **without** starting the engine (key on, engine off).
 - If the DTC(s) come right back, there's likely a problem in the rocker arm oil pressure switch circuit. Go to step 3.
 - If the DTC(s) don't come back, the rocker arm oil pressure switch circuit is probably OK. Go to step 4.
3. Unplug the **rear** rocker arm oil pressure switch 1P connector for DTC P3400, or the **front** rocker arm oil pressure switch 1P connector for DTC P3497. Go to the **PGM-FI Data List**, and check the **ROCKER ARM OIL PRESSURE SWITCH** signal.

- If the switch signal reads **OFF**, the wiring is OK. Replace the oil pressure switch. Then, plug in the connector and make sure the DTC(s) don't come back.
- If the switch signal reads **ON**, there's a problem in the wiring or the PCM. Continue with the normal DTC troubleshooting in ISIS.

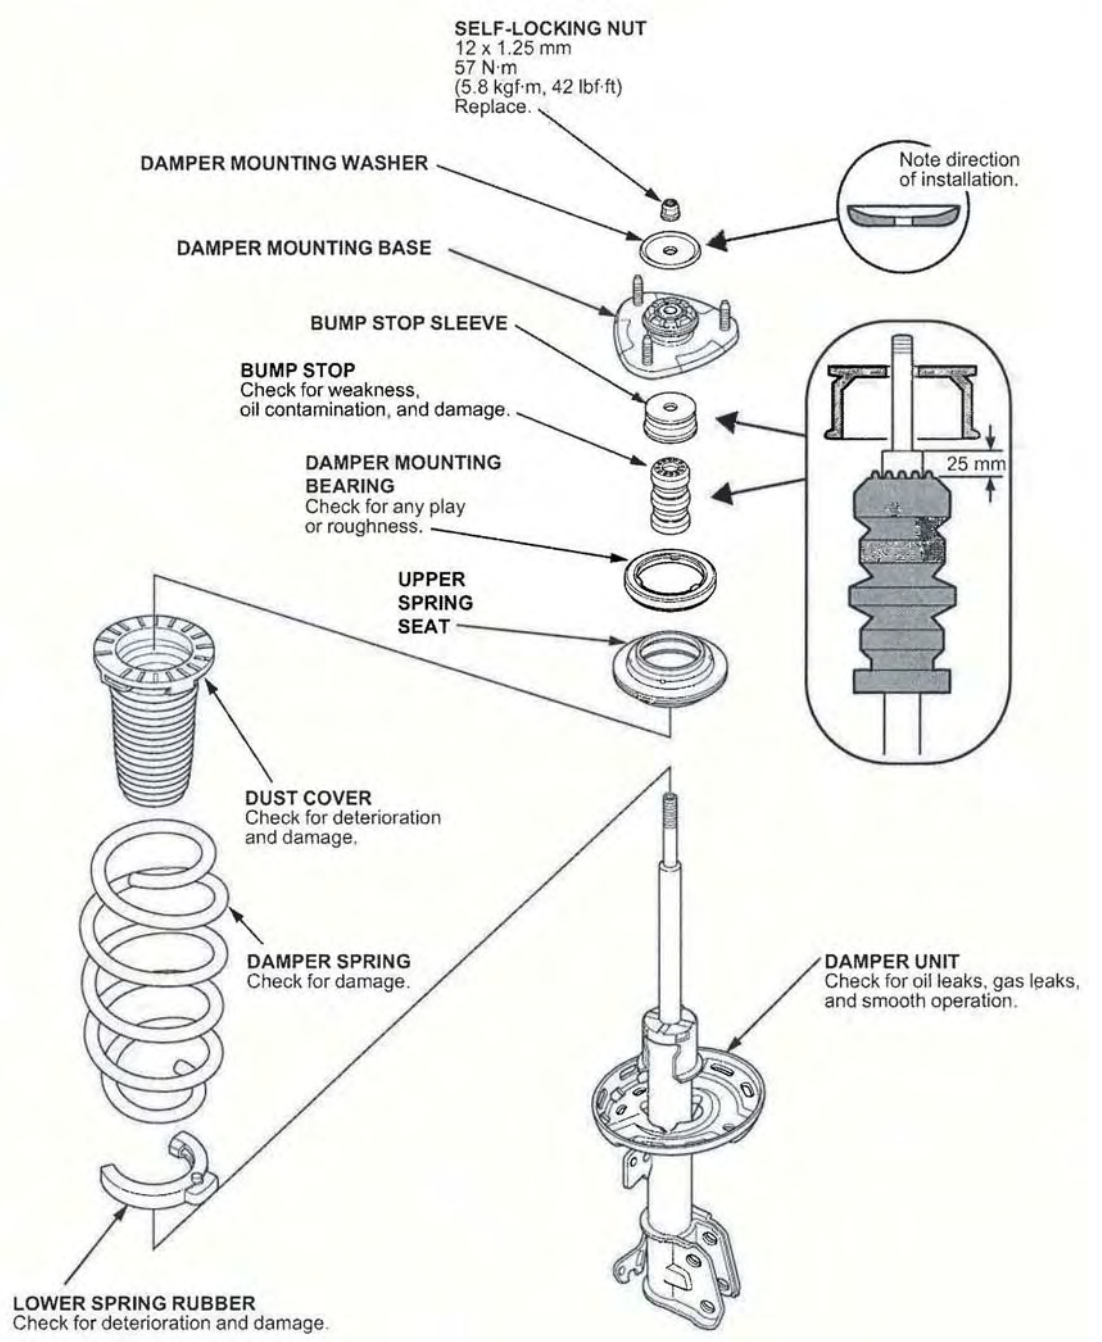
- Install the bump stop so the top of the stop is about **25 mm** below the damper shaft shoulder. If you don't leave that space, the bump stop could get pinched between the bump stop sleeve and the shoulder, which could lead to damper shaft failure.
- Install the bump stop sleeve with its opening facing down (flat side up).
- Install the damper mounting washer with its concave side facing up.
- Make sure you're using the right self-locking nut, and torque it to **57 N·m (42 lb-ft)**.

Repairing a front damper/spring? Here's something you should know: We've increased the self-locking nut torque spec for 2009–11 models from 44 N·m (33 lb-ft) to **57 N·m (42 lb-ft)**. This matches the spec for 2012 models.

- After installing the damper/spring onto the frame, make sure you fully compress the front suspension one time to position the bump stop against the sleeve. Driving over a speed bump, through a dip, or pulling into a driveway will usually do the trick.

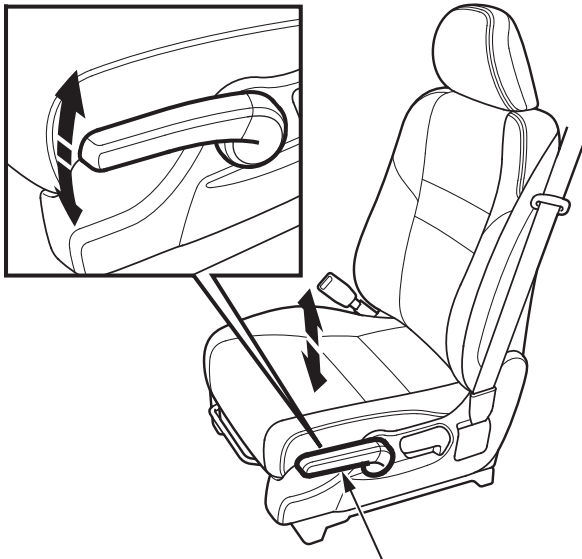
SEAT HEIGHT ADJUSTMENT LEVER

Got a driver's seat that seems to mysteriously lower itself over time? The culprit could be your customer, **not** the seat. The seat lowers when you push down repeatedly on the seat height adjustment lever. Chances are your customer is brushing against it when getting in or out of the vehicle.

1. Set the seat height to where your customer normally likes it.
2. Remove the seat height adjustment lever.
3. Return the vehicle to your customer.
