# GRANT SAWYER OFFICE SITE

555 East Washington Ave.  
Las Vegas, Nevada 89101

**Site Number: 9835**  
**STATE OF NEVADA PUBLIC WORKS DIVISION**  
**FACILITY CONDITION ANALYSIS**

Report distributed in October 2021

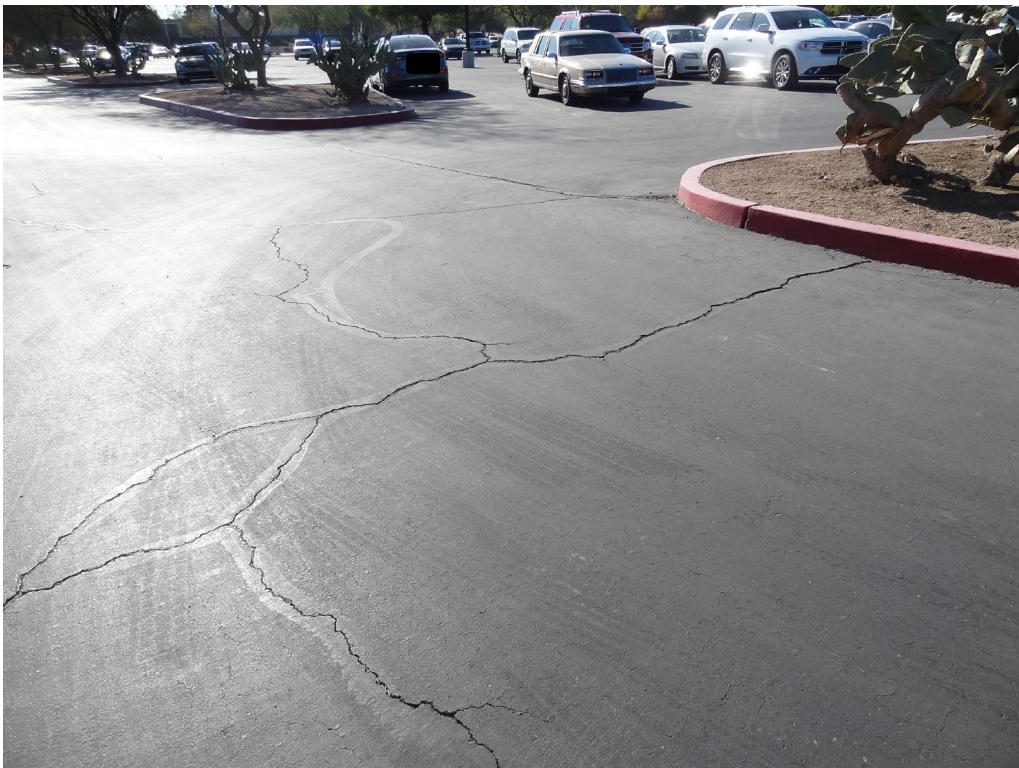
It is important to maintain the asphalt concrete paving on the site. This project would provide for minor replacement of deteriorated paving, minor crack filling and slurry sealing of the paving site wide. Striping is included in this estimate. This project should be scheduled on a 5 year cyclical basis to maintain the integrity of the paving and prevent premature failure. 400,000 square feet of asphalt area was used to generate this estimate.

Grant Sawyer Office Site - Site #9835  
Description: Asphalt Crack Fill & Seal Needed

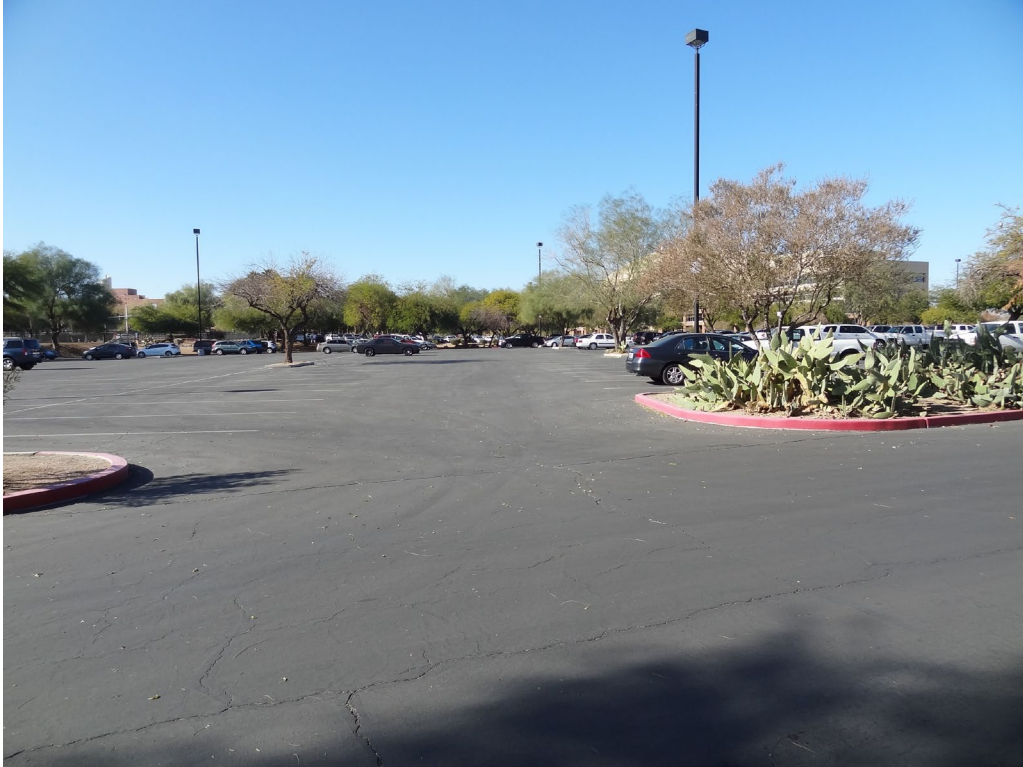
There are approximately seventeen existing light poles around the site. The existing light fixtures are the older high pressure sodium type. These are costly to replace and are not energy efficient. It is recommended to upgrade the fixtures to higher efficiency units with a longer life cycle. This project would provide for the replacement of the existing light fixtures with LED fixtures using the existing wiring and poles. This project or a portion thereof was previously recommended in the FCA report dated 04/27/2011. It has been amended accordingly to reflect conditions observed during the most recent survey date of 12/14/2017.

**Grant Sawyer Office Site - Site #9835**  
Description: Site Lighting Upgrade Recommended.

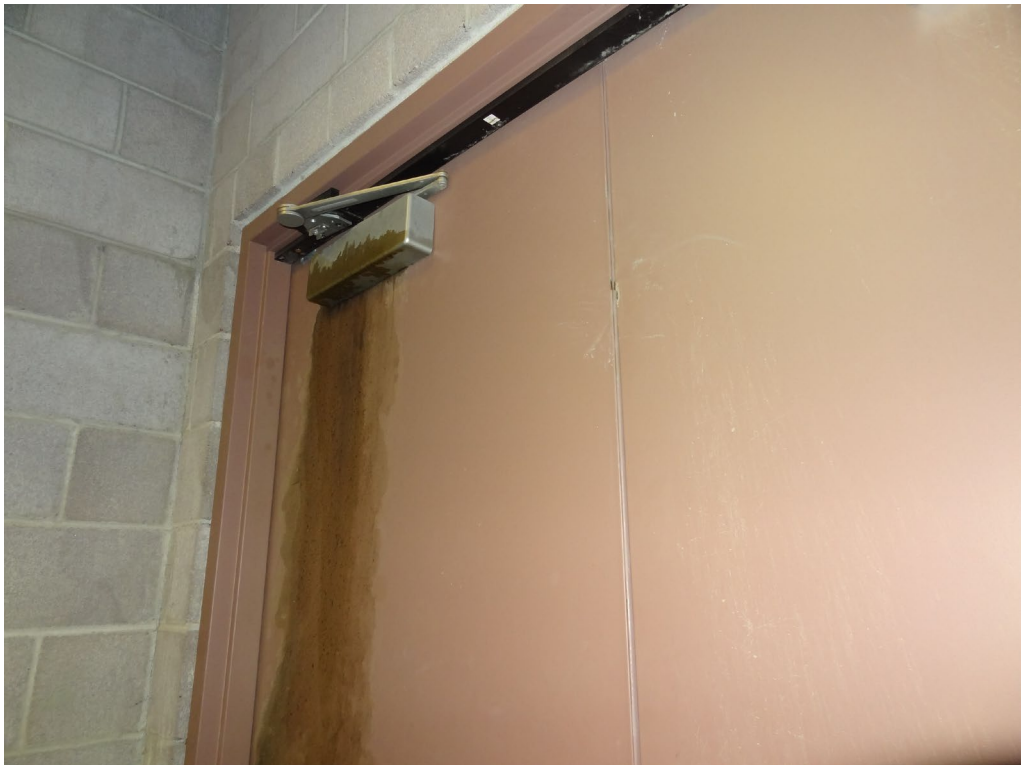
The exterior oversized metal door(s) are in good shape, however the door closures are failing. The closures are damaged from age and general wear and tear and have reached the end of their useful life. This project would provide for the replacement of the closure on eight doors. Removal and disposal of the existing hardware is included in this estimate.

Grant Sawyer Garage / Pump House - Building #3099  
Description: Door Hardware Replacement Needed.

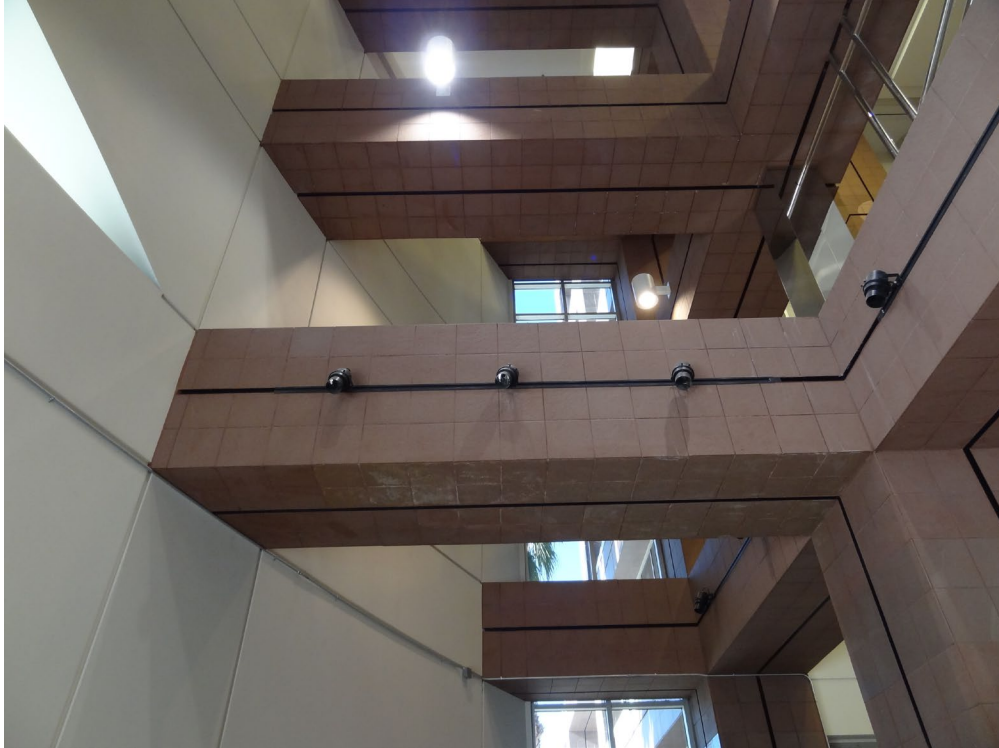
The interior finishes are in fair condition. It is recommended that the interior walls and ceilings be painted at least once in the next 4 - 5 years and that this project be scheduled on a cyclical basis to maintain the integrity of the structure. Prior to painting, all surfaces should be repaired and prepped. An epoxy-based paint should be utilized in wet areas for durability.

Grant Sawyer State Office - Building #1680  
Description: View of Interior and Interior Finish Issues.

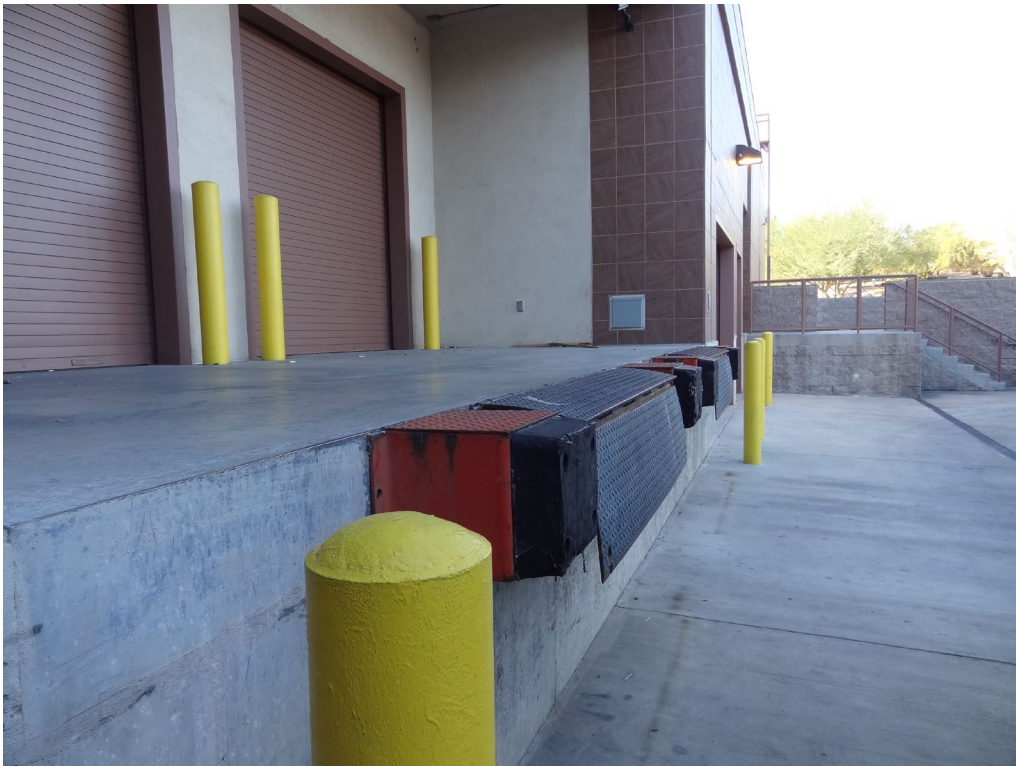
The existing loading dock does not accommodate smaller delivery trucks requiring personnel to lift equipment onto the loading dock. The loading dock is also missing a ramp which would provide for some of the smaller deliveries to be wheeled up. Gaming Commission deliveries must be brought into the building through the building's rear personnel door which poses a security risk. This project would install a powered 6' x 8' loading dock lift and a concrete ramp for smaller deliveries in place of the damaged stairs.

Grant Sawyer State Office - Building #1680  
Description: Loading Dock Lacking Parcel Delivery Size Ramp.

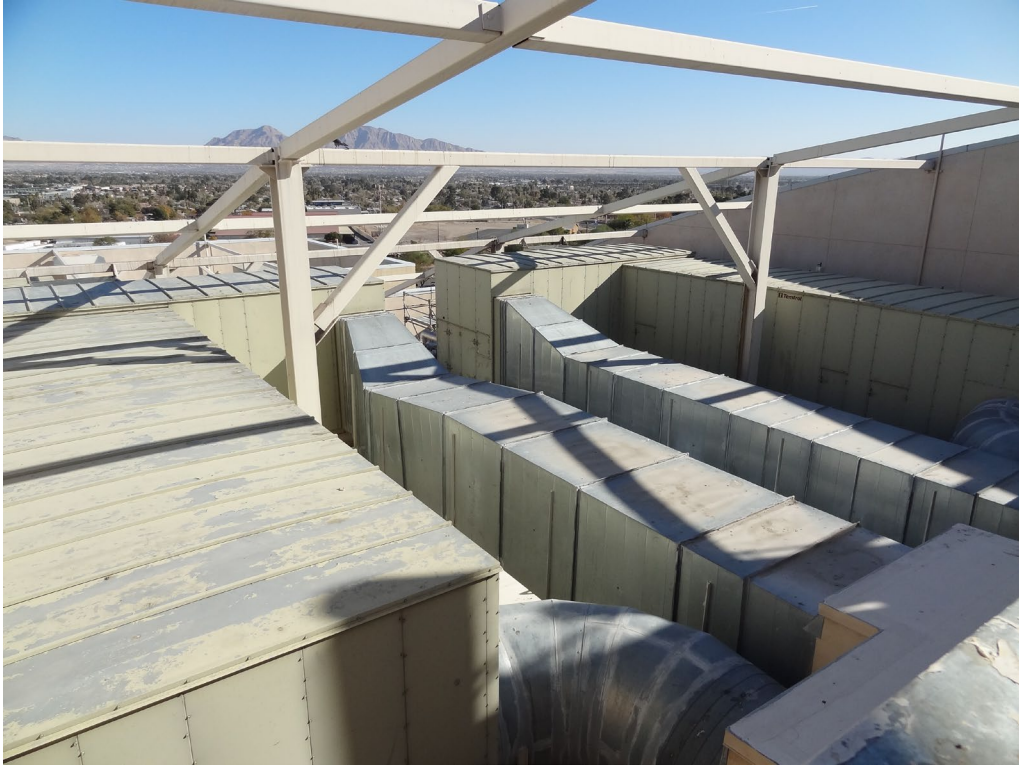
With the exception of the Central Heating & Cooling Plant, the entire HVAC system is original to the 1995 building construction. The equipment has consistent problems and has reached its expected life. This project recommends the replacement of eight air handlers, exterior ductwork, hydronic piping, terminal units, fan coils, adding a kitchen makeup air system and temperature control system. It is recommended that this project be implemented in the next 3 - 4 years to avoid possible failure. This project would also provide for all demolition, cranes and rigging, testing and commissioning.

Grant Sawyer State Office - Building #1680  
Description: Air Handling Units & Exterior Ductwork Needing Replacement.

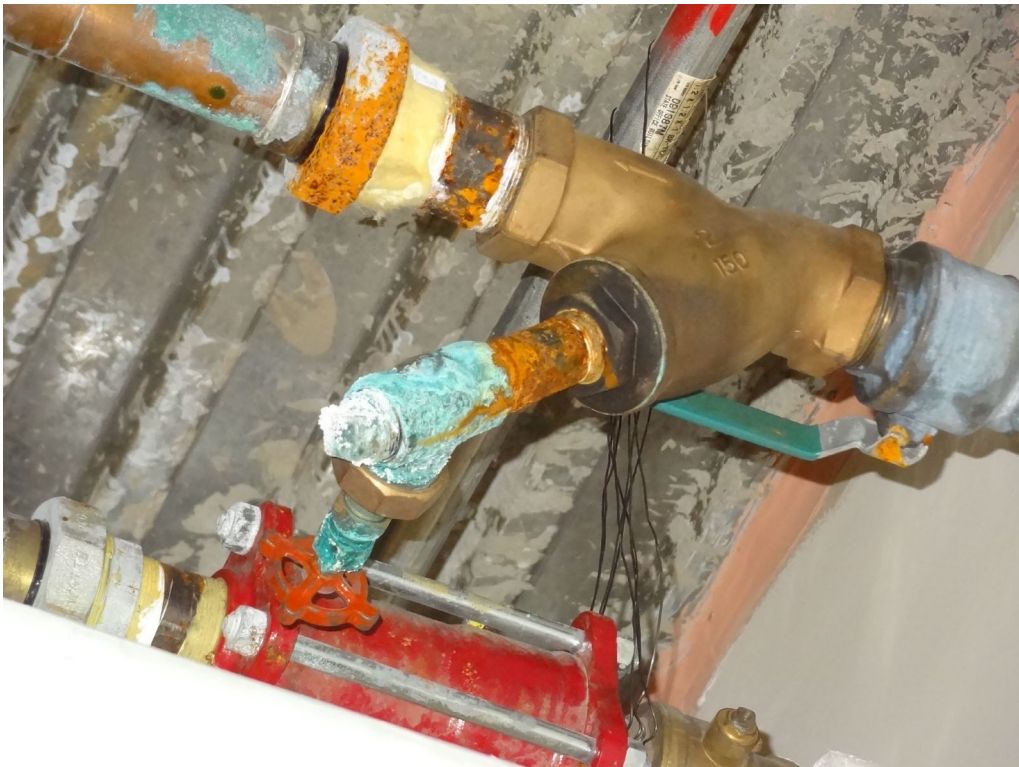
The domestic plumbing and sanitary waste systems in the building are in poor condition. The domestic system appears to be original to the building, are leaking and should be scheduled for replacement. The sewer lines have deteriorated and are failing. This project recommends replacing all domestic and sanitary lines in the building. This estimate includes demolition, removal and disposal of the existing system.

Grant Sawyer State Office - Building #1680  
Description: Mechanical Piping Replacement Needed.

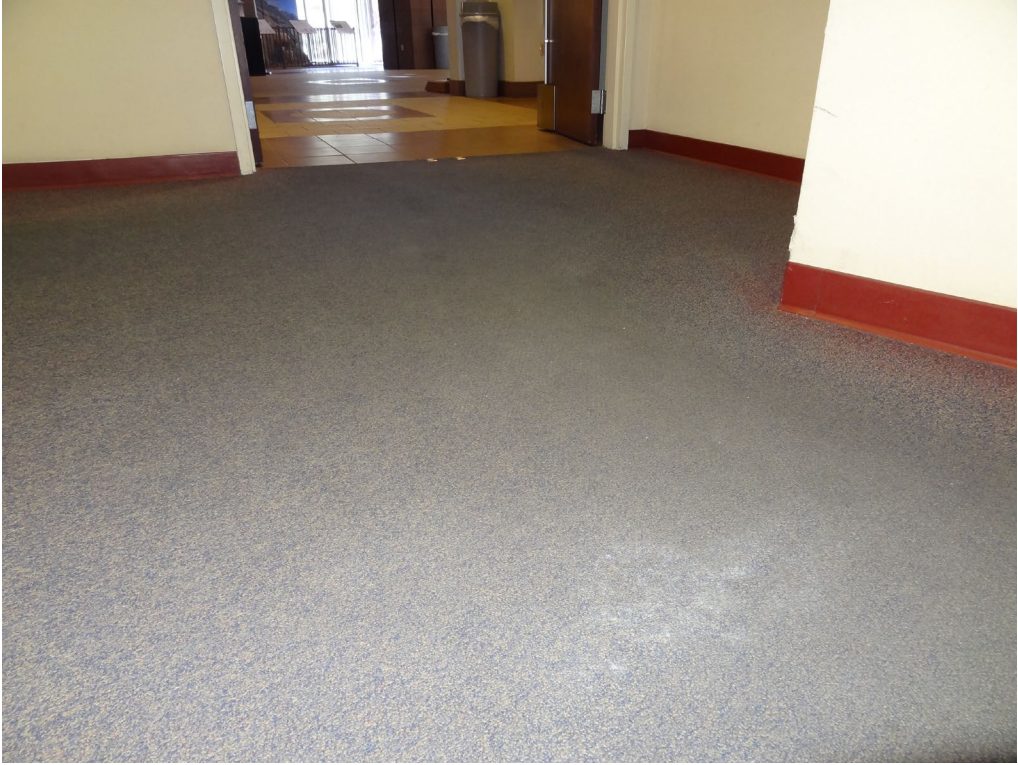
The VCT (vinyl composite tile) and carpet in the building are damaged and reaching the end of their useful life. It is recommended that the flooring be replaced. This project would provide for removal and disposal of the existing flooring and installation of new 12x12 VCT with a 4" base and heavy duty commercial grade carpet in the next 2-3 years.

Grant Sawyer State Office - Building #1680  
Description: Flooring Replacement Needed.

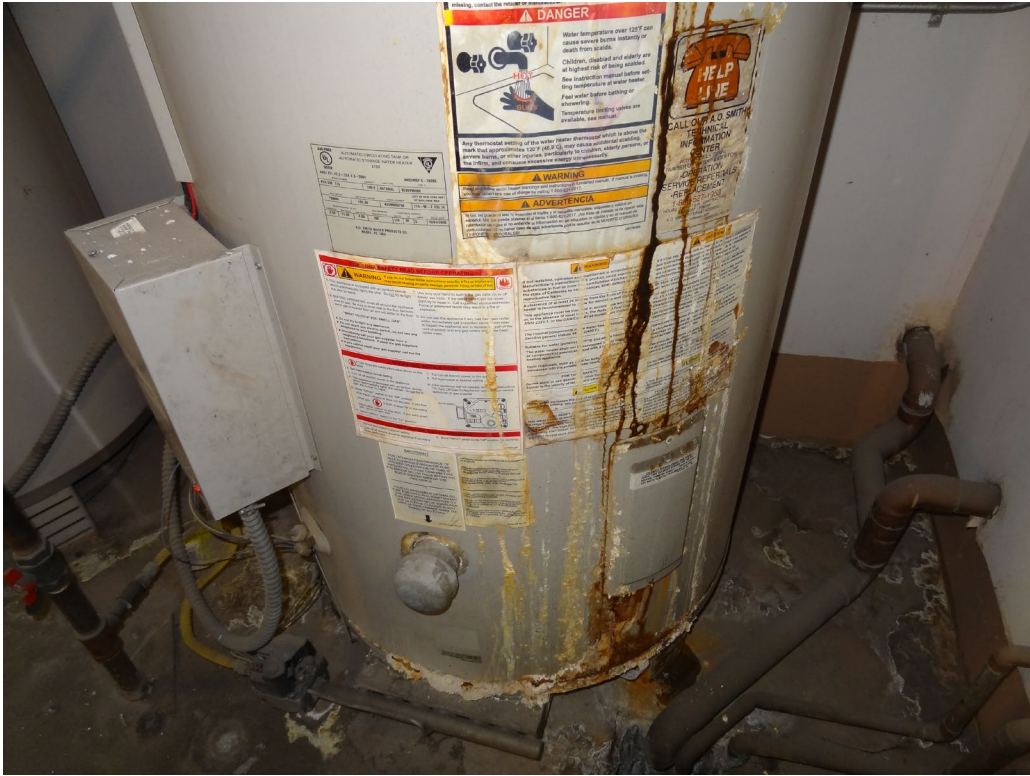
Three of the four 100 gallon gas-fired water heaters in the boiler room have been replaced recently. The average life span of a water heater is eight to ten years. With the passage of time and constant use, the older unit is showing signs of wear and should be scheduled for replacement in the next 2-3 years. It is recommended that a new gas-fired water heater be installed. The other three water heaters in the room have been replaced recently, but do not have seismic straps installed. This project includes seismic straps for all four water heaters. Removal and disposal of the existing equipment is included in this estimate.

Grant Sawyer State Office - Building #1680  
Description: Water Heater Replacement Needed.
