BULLETIN

BULLETIN NUMBER:
CB16-J-003

IMPORTANT SAFETY RECALL

STOPPER BRACKET INSTALLATION – 16V-797

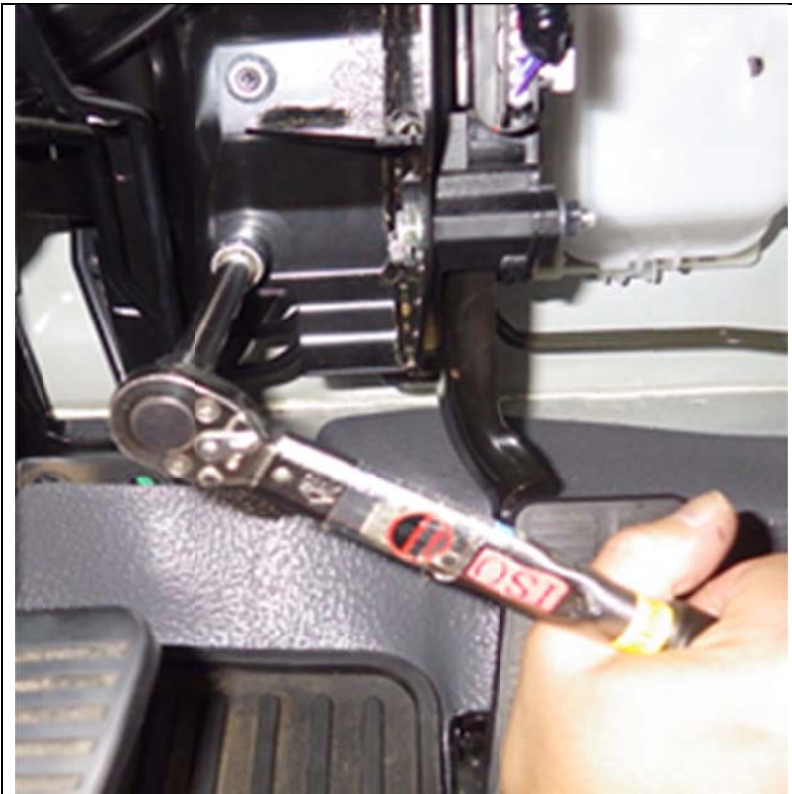
Figure 1 – Tighten Accelerator Pedal

1. Set the parking brake, remove the key from the ignition and block the front wheels in a well-lit area.
2. Tighten the two (2) accelerator pedal mounting nuts (see Figure 1) to 18 Nm (13 ft. lb.).

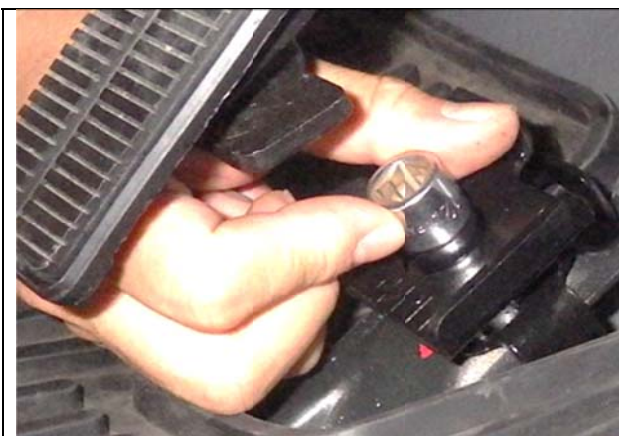
Figure 3 – Temporary Bracket Installation

4. Temporarily install and hand tighten the new stopper bracket using the new bolt provided (see Figure 3). When tightened (even by hand), the head of the new mounting bolt should be below the flat surface of the new stopper bracket. Be sure the stopper bracket is aligned properly (see Figure 4).

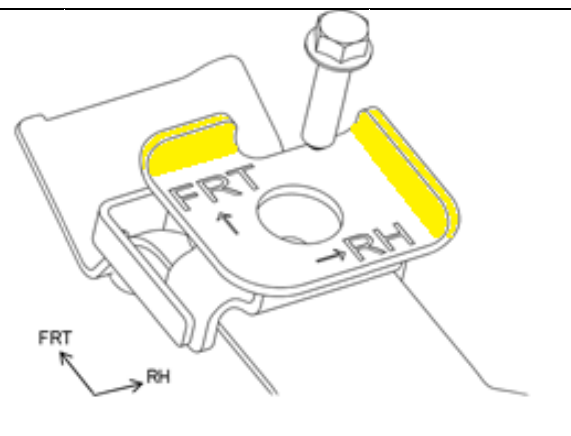
Figure 4 – Stopper Bracket Alignment. Yellow indicates stopper bracket flange.

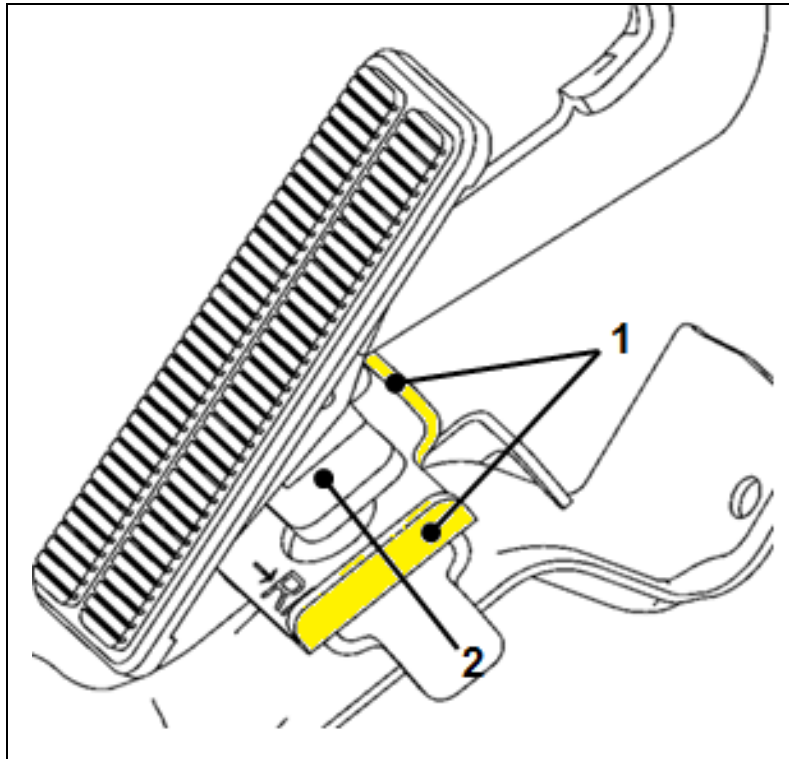
Figure 5 – View From Right Side

1. Flange (in yellow)
2. Stopper Plate

5. Depress the accelerator and ensure the stopper plate does not hit the flanged area of the stopper bracket (see Figures 5 and 6).

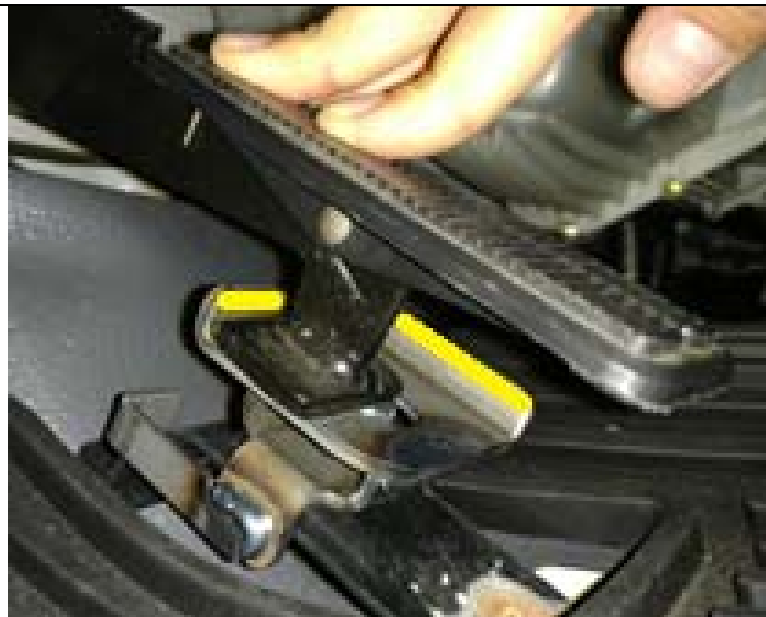
Figure 6 – View From Left Side. Yellow indicates stopper bracket flange.

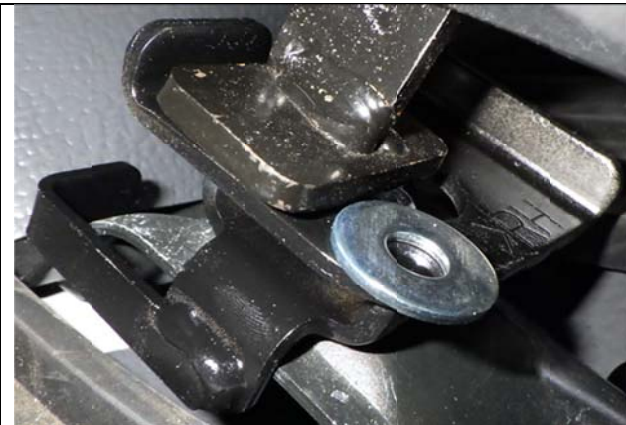
Figure 7 – View From Left Side

- a. If the stopper plate contacts the stopper bracket, torque the mounting bolt to **22Nm (16 ft. lb.) and go to Step 7.**
 - b. If the stopper plate does not contact the stopper bracket, check the clearance by depressing the pedal to WOT and attempting to insert one of the washers provided with the stopper bracket between the stopper plate and the stopper bracket (see Figure 7).

- i. If the washer does not fit between these two parts, the clearance between the stopper plate and stopper bracket is less than 2mm and no adjustment is necessary. Torque the mounting bolt to **22Nm (16 ft. lb.) and go to Step 7.**

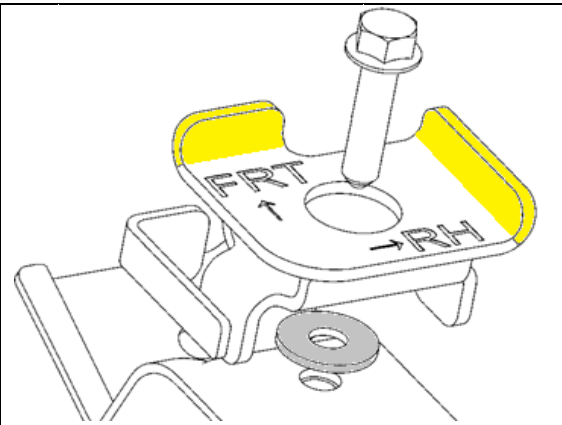
Figure 8 – View From Left Side. Yellow indicates stopper bracket flange.

- ii. If the washer does fit between these two parts, remove the stopper bracket and add the washer between the stopper bracket and the floor (see Figure 8), and reinstall. This will adjust the clearance. Check the clearance again by repeating Step 6 with the second washer and follow the results.
