Main rotor tip strike involving Eurocopter AS350-BA, VH-PHU

9 km WNW of St. Leonards (ALA), Victoria, 4 July 2017

ATSB Transport Safety Report
Aviation Occurrence Investigation
AO-2017-074
Final – 28 February 2018

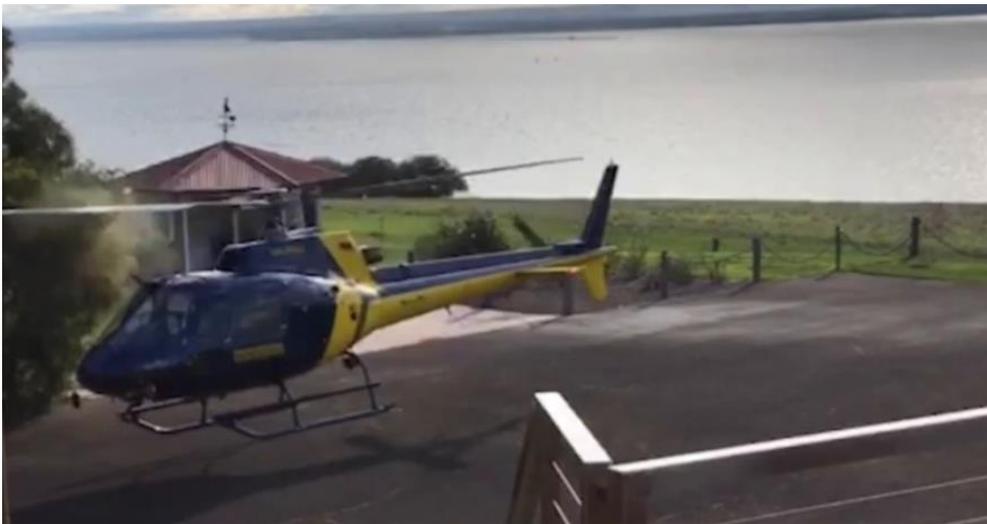
On 4 July 2017, a Eurocopter AS350-BA helicopter, registered VH-PHU and operated by Professional Helicopter Services, was chartered to conduct a flight between Moorabbin Airport and the Jack Rabbit Vineyard helicopter landing site (HLS)^{1,2} on the Bellarine Peninsula, Victoria. At about 1415 Eastern Standard Time,³ while landing at the HLS, the tips of the helicopter's main rotor blades struck an encroaching bush (Figure 1).

Figure 1: Smart phone footage of the main rotor blade tip strike (into bush)

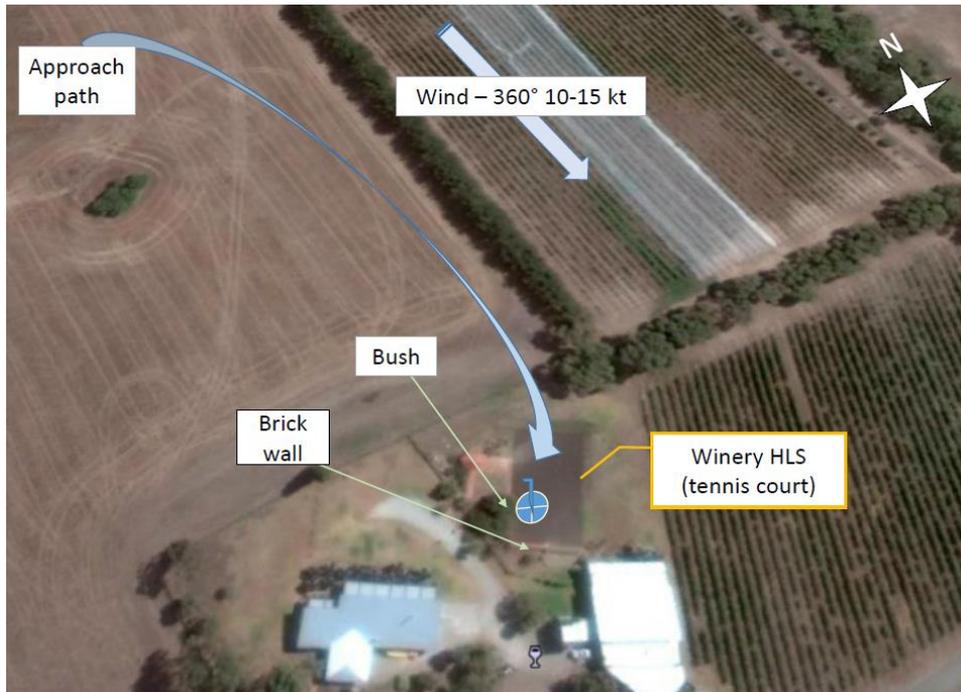
During the approach, the pilot identified the key boundaries of the landing site, which included a brick wall at the southern end of the site, but he did not see a large bush that encroached into the HLS. When established in the HLS, and believing that he had to make way for another helicopter, the pilot slowly hover-taxied the helicopter forward towards the south-west corner of the landing site. During this, the pilot reported that he remained focused on the brick wall ahead (Figure 2).

Figure 2: Jack Rabbit Vineyard HLS

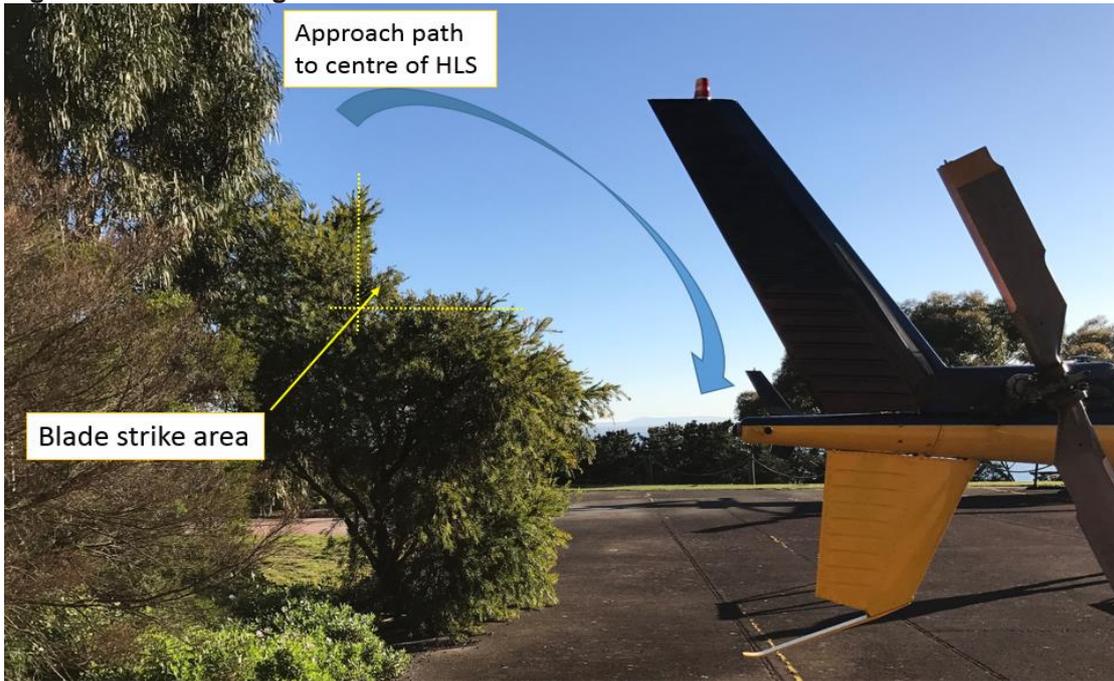
At about 1415, the tips of the helicopter’s main rotor blades struck the encroaching bush (now on the helicopter’s right side) (Figure 3). The pilot initially landed the helicopter, then soon after repositioned clear of the bush.

Figure 3: Encroaching bush in the HLS and the main rotor blade strike area

The pilot's confidence in his abilities influenced his decision to conduct an abbreviated reconnaissance of the HLS. This removed an opportunity to observe the encroaching bush. This, combined with the pilot's focus of attention on the brick wall in front of the helicopter when landing, meant that he was not aware of the bush to his right.

Further, the pilot believed that another helicopter was also landing at the HLS and he elected to hover-taxi to the south-west corner of the site to provide room for that helicopter. However, as the pilot was not aware of the encroaching bush when conducting this manoeuvre, the helicopter's main rotor blades struck the bush.

- An abbreviated reconnaissance of the helicopter landing site, along with a focus of attention on other obstacles within proximity, resulted in the pilot not being aware of a bush encroaching the helicopter landing site and the helicopter's main rotor blades striking the bush.

- reviewed internal flight tasking processes
- updated and upgraded internally provided HLS documentation, and provided this information electronically (iPad)
- learning outcomes from this incident are to be incorporated into future practices and disseminated to all pilots and aircrew.

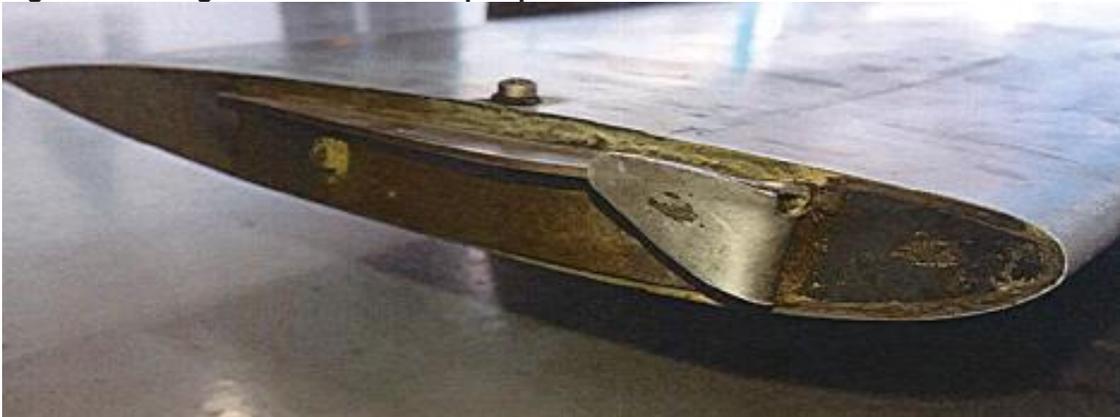
The helicopter was subsequently shut down and secured without further incident. There were no injuries. All three of the helicopter's main rotor blade tip caps were found damaged (Figure 4). The sequence of the incident was captured on a smart phone and subsequently reviewed by the ATSB.

Figure 4: Damage to VH-PHU rotor tip caps
