SAFETY RECALL BULLETIN

SUBJECT:		No: SR-15-002	
ETACS ECU – SAFETY RECALL CAMPAIGN		DATE: June, 2015	
		MODEL: See below	
CIRCULATE TO:	<input checked="" type="checkbox"/> GENERAL MANAGER	<input checked="" type="checkbox"/> PARTS MANAGER	<input checked="" type="checkbox"/> TECHNICIAN
<input checked="" type="checkbox"/> SERVICE ADVISOR	<input checked="" type="checkbox"/> SERVICE MANAGER	<input checked="" type="checkbox"/> WARRANTY PROCESSOR	<input checked="" type="checkbox"/> SALES MANAGER

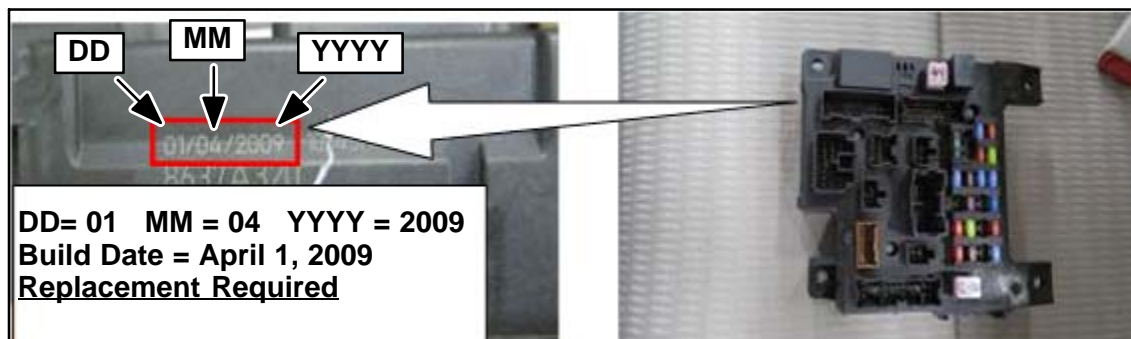
6. Check the production date (DD/MM/YYYY) on the left side of the ETACS ECU.

- If the production date is September 30, 2008 or earlier (30/09/2008), **replacement is NOT required.**
 - If the production date is September 1, 2010 or later (01/09/2010), **replacement is NOT required.**
 - If the production date is from October 1, 2008 to August 31, 2010 (01/10/2008 – 31/08/2010), **replacement is required.**
7. If required, replace the ETACS ECU with the corresponding part number shown in the **Parts Section**.
8. Reinstall the ETACS ECU. Torque to 36 ± 17 in-lb (4.0 ± 2.0 N-m). Reconnect the wiring connectors as follows:
