Service Bulletin

Bulletin No.: 18-NA-383

Subject: Water Found in Rear Interior of Cab, Water Leak at Rear Sliding Window

Brand:	Model:	Model Year:		VIN:		Engine:	Transmission:
		from	to	from	to		
Chevrolet	Silverado 1500 (New Model)	2019	2019	SOP	Prior to October 1, 2018	All	All
GMC	Sierra 1500 (New Model)

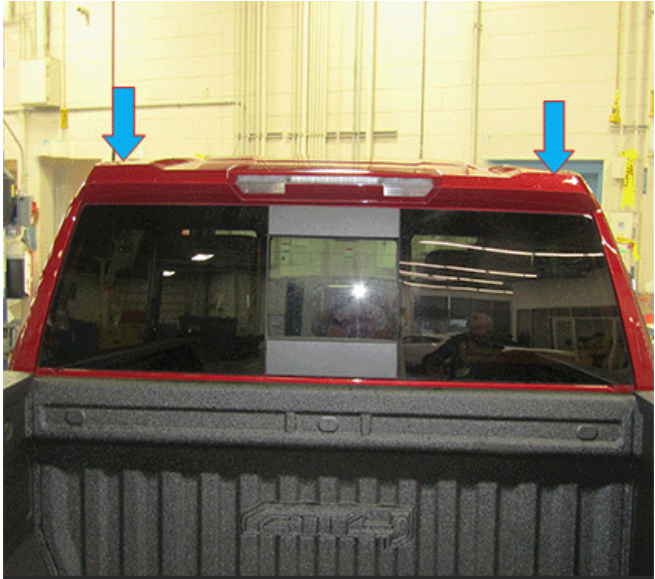
5203798

The cause of the condition may be cracking in the rear sliding window plastic upper rail glass guide. The plastic upper rail glass guide may develop small fractures/cracking which allows water to pass through on the glass side of the urethane that attaches to the vehicle body.

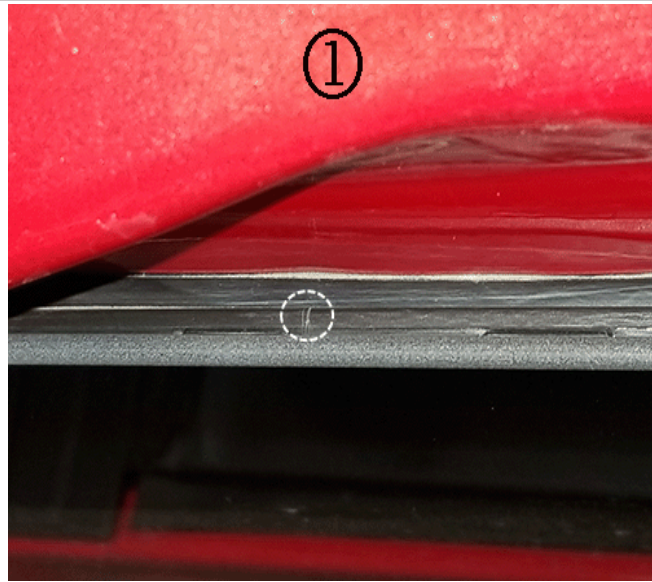
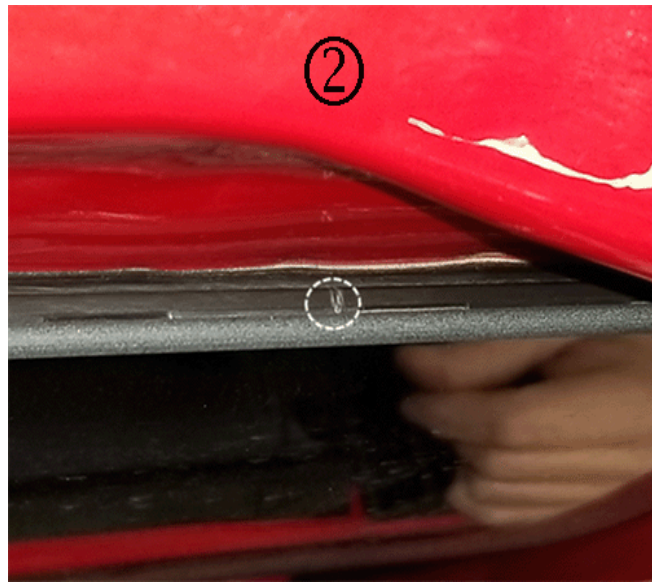
Note: The cracks can be in the left and/or right side of the rear sliding window plastic upper rail glass guide which is covered by the roof rear spoiler. Examples of a left (1), then right side (2) visual crack (with the spoiler removed) are shown in the graphics above.

R & R the roof rear spoiler and apply seam sealer to the rear sliding window top encapsulate, following the steps in the Service Procedure below.
