Service Bulletin

Bulletin No.: 20-NA-012

Subject: Radio Software Version V135116 Over-the-Air Update

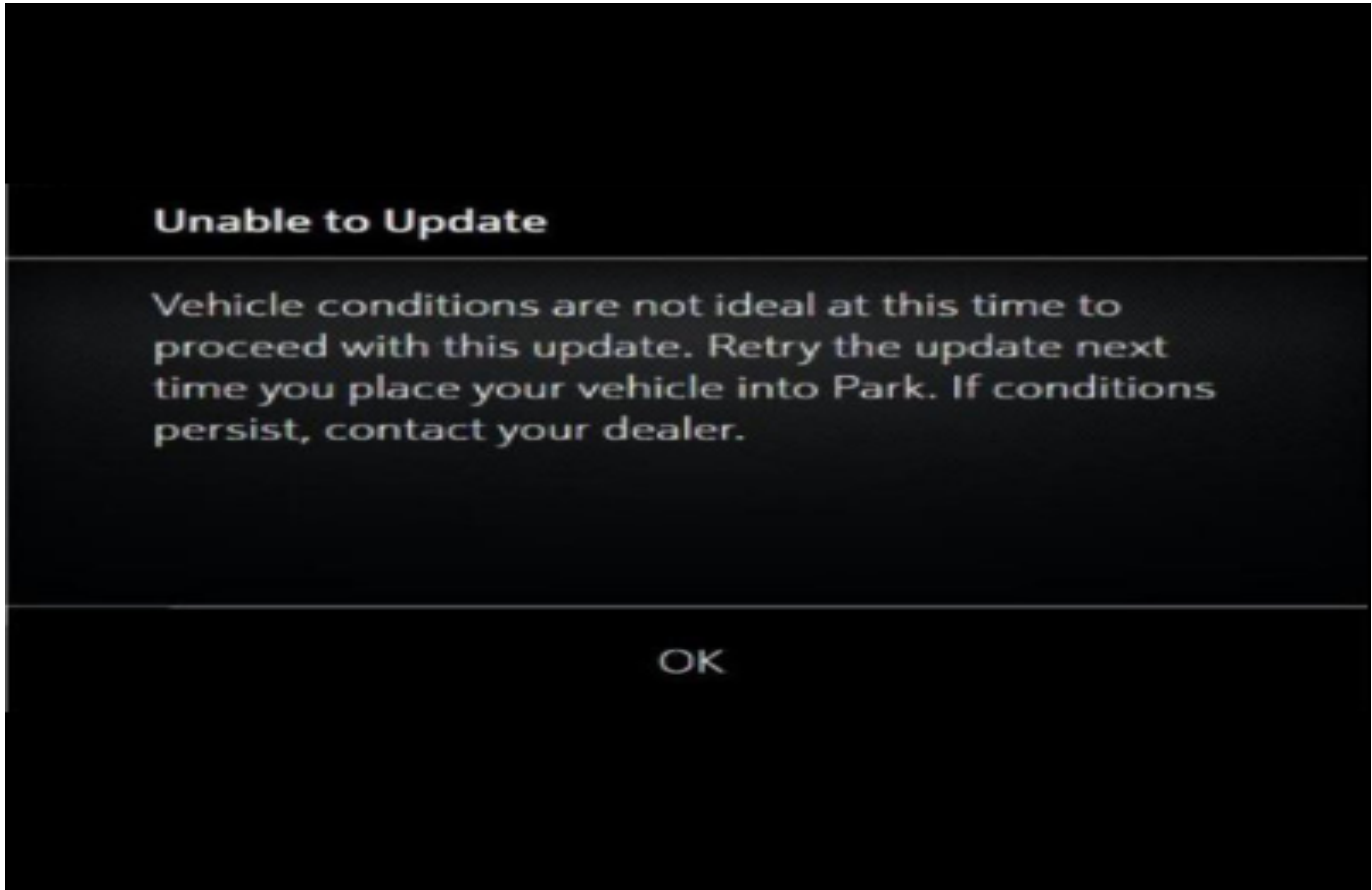
5495032

Scenario 1: Vehicle conditions are not ideal.

If the above screen is shown, download the update through TIS2Web and perform USB update. Ensure the vehicle battery is being maintained (using EL-49642 or battery maintainer) while performing this update.

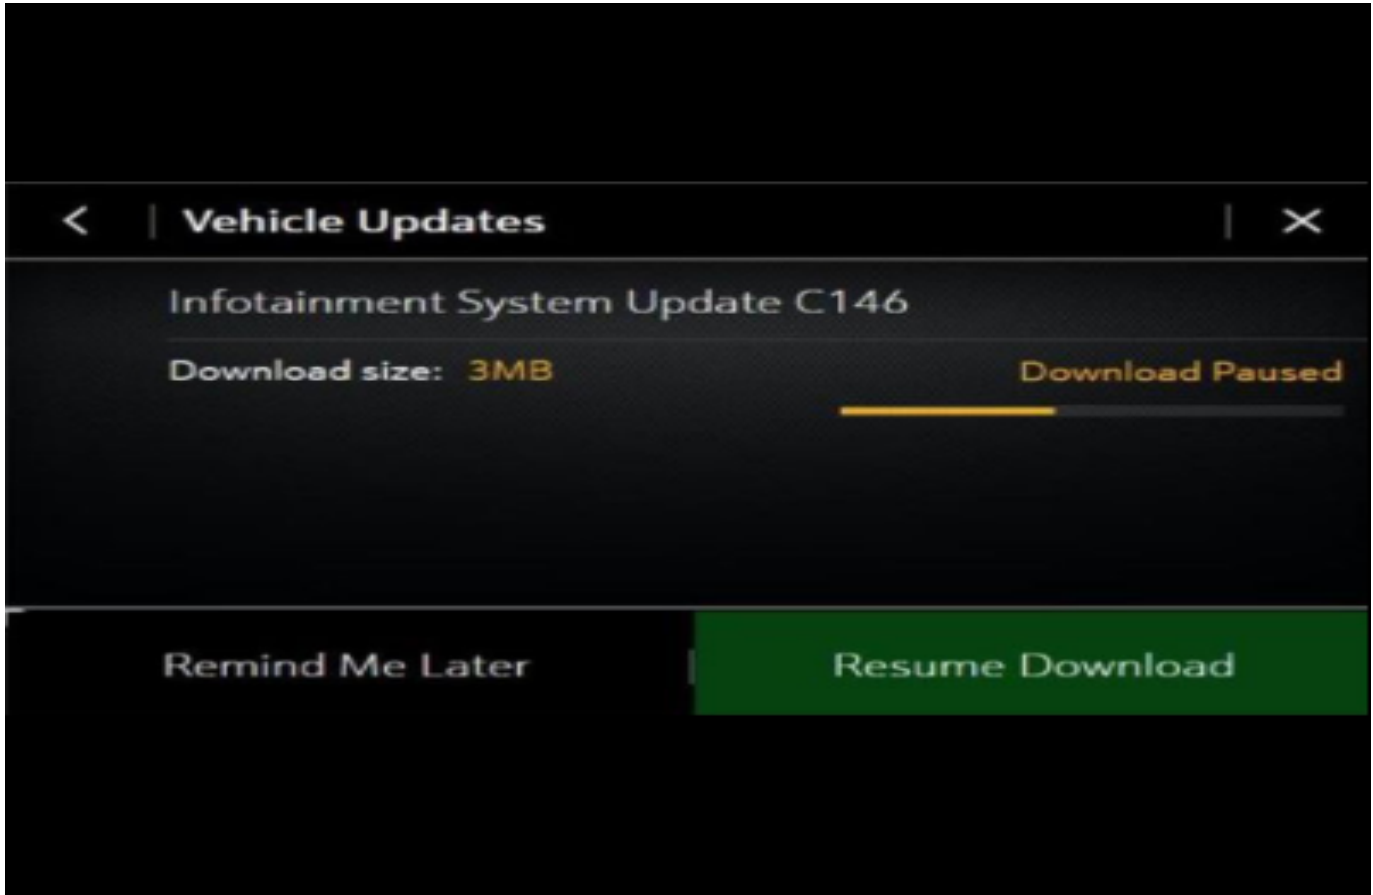
5494724

Scenario 2: Consistently Paused Download

If the above screen is shown and resuming the download repeatedly fails, a USB update will need to be performed. Turn the vehicle on, return to the home screen, and insert USB stick (see previous section). Verify the part number is correct and follow on screen prompts.

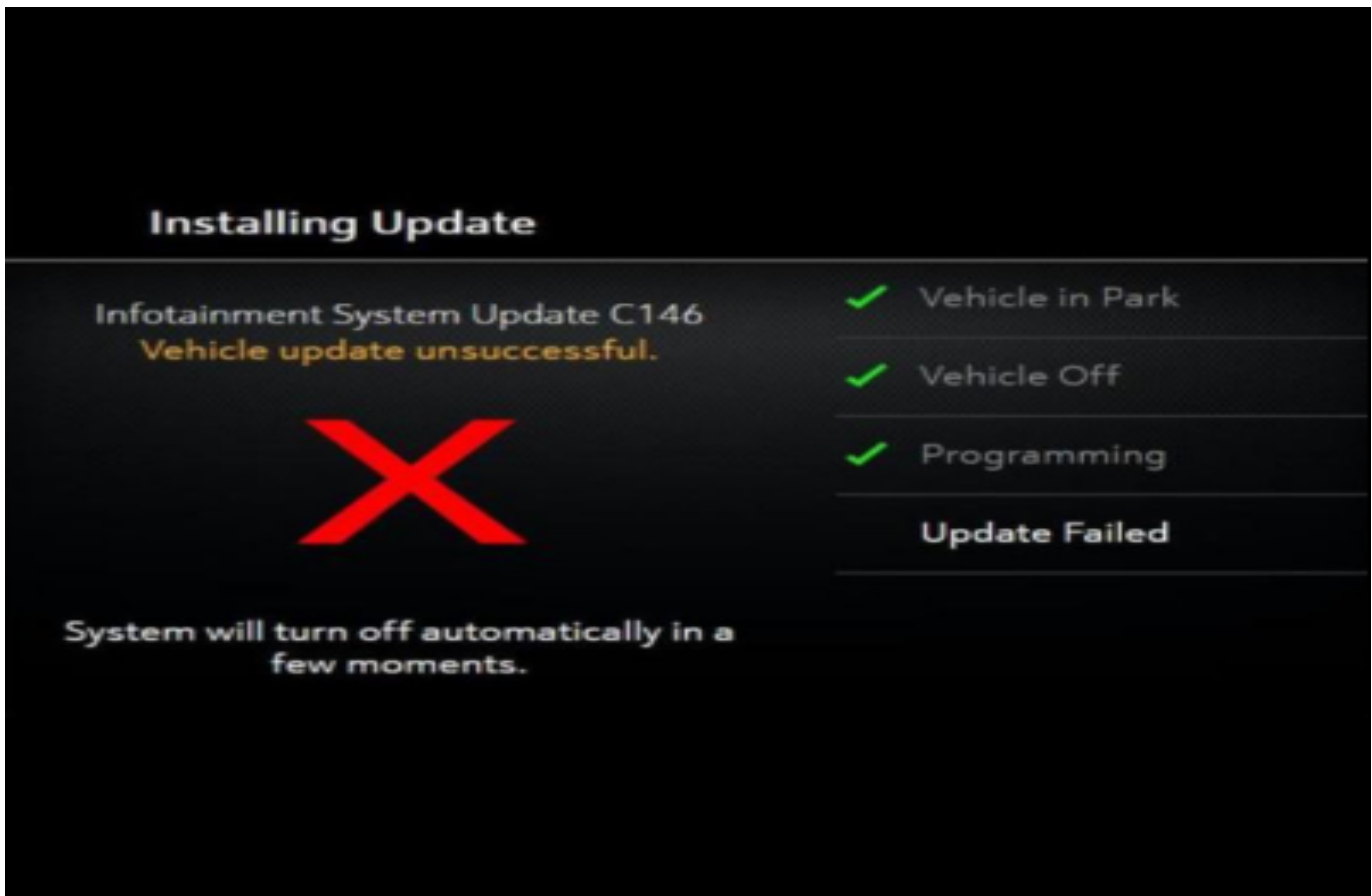
5494708

Scenario 3: Update Failed. Return to dealer screen.

Update Failed

%The software update has failed. Contact your dealer for assistance with installing this update.%

- If one of the above screens is shown, download the update through TIS2Web and insert a USB stick into the radio. A yellow progress bar should come on the screen and the update will proceed. If this screen above is shown when trying to update the radio through USB, reformat the USB drive to FAT32 on your PC, perform Return to Factory Defaults, and then try to download the update through TIS2WEB again.
