# Common Codes and Corrections for the Allison LCT 1000

by Steve Garrett

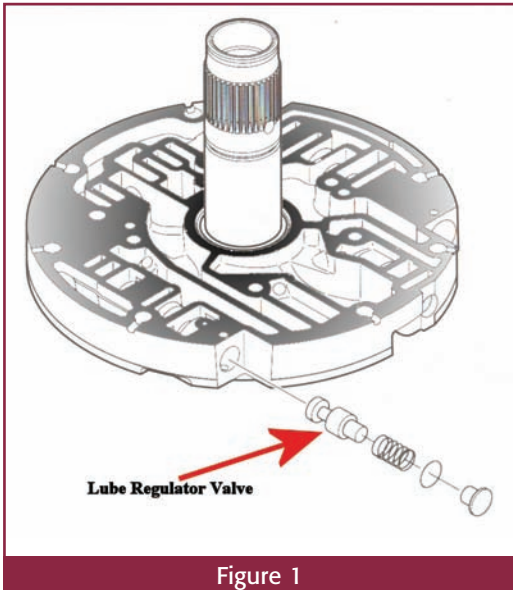
Figure 1

- Inspect for a sticking or damaged main regulator valve.
- Inspect for a sticking or damaged lube regulator valve (figure 1). An updated valve kit is available for earlier applications under GM part number 88996718. This kit is designed to reduce the chance of air

being drawn into the converter circuit, which will affect the unit's ability to prime properly.

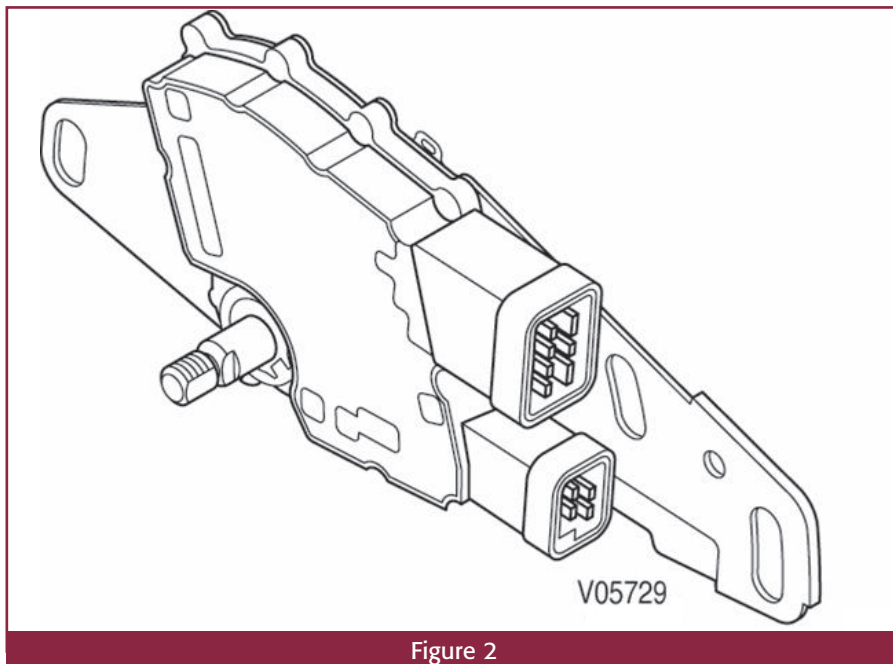
Figure 2

This code indicates a problem with the neutral safety backup (NSBU) switch or its circuits (Figure 2). In most cases several other codes will set along with P0708, including P0847, P0872, P0875, P1711, P1713 or U1000. In addition, other symptoms may be present, such as:

- TCM calibration; an updated calibration has been released for early models.
- The neutral safety backup switch and shifter cable adjustments.
- Check for moisture in the neutral safety backup switch. This is very common with the early, 2-connector NSBU switch. The updated switch is available; GM part number 29540479.
- Missing or improperly installed neutral safety backup switch shields.
- The neutral safety backup switch wasn't fully installed onto the shifter shaft. Inspect

for burrs or damage to the shaft.
