In situ metallography as non-destructive test to analyze the microstructural damage in the petrochemical industry

Abstract

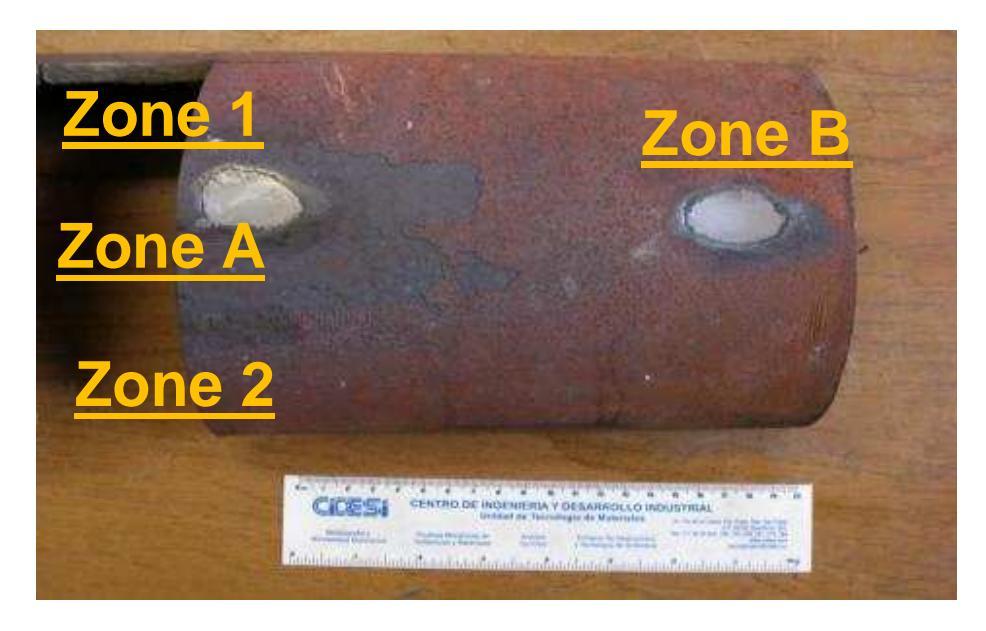
Figure 1. The image shows the failed tube, where the samples and the in situ metallographies were taken. It can be seen the location of Zone A, Zone B, Zone 1, and Zone 2.

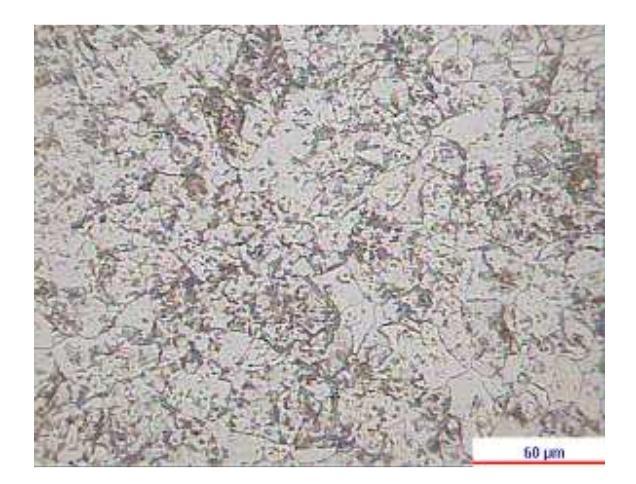
Figure 2. The micrograph shows at 500X the microstructure of the damaged tube in Zone 1.

Figure 2 shows the typical microstructure of an overheated steel tube, which consisted of elongated pearlite and carbides precipitated on the grain boundary (this microstructure helps to understand the cause of the failure of this tube, nevertheless, it is not the aim of this paper to discuss the failure due to overheating). Here must be mentioned that the dark regions of the microstructure are not pearlite regions; one must keep in mind that the microstructure was taken very near the failure due to overheating and this tube suffered thinning, therefore the middle plane is near the external surface where a layer of fire residuals were deposited; normally this deposits layer react with the steel of the tube leading to such appearance.

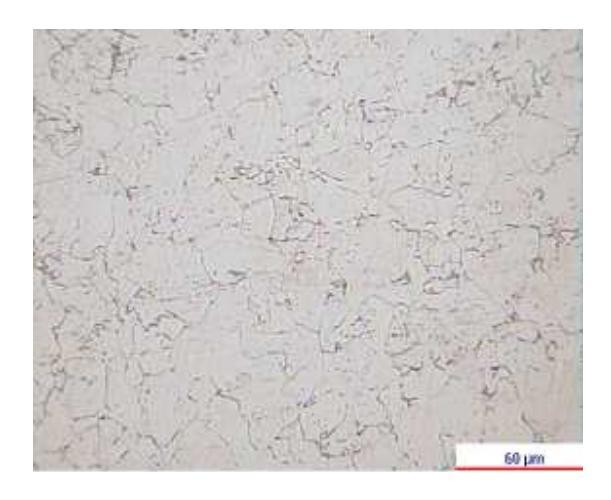
Figure 3. The micrograph shows at 500X the microstructure of the damaged tube in Zone 2.

Figure 3 shows the microstructure away from the bulging of the tube. This microstructure shows evidence of no strong carbide precipitation in the boundary between phases. In this case the pearlite cannot be distinguished because the sample was etched using Vilellas etching during the same time as in the microstructure of Zone 1. This is due to the fact that longer etching times in Zone 1 led to overetching and no microstructure was revealed. Besides, it is important to mention that in case of microstructure of Figure 3 the boundary showed on the micrograph was delimitated by the etching and not by carbide precipitation

as it is the case in Figure 2. The important fact of this microstructure is that the phases are not elongated.

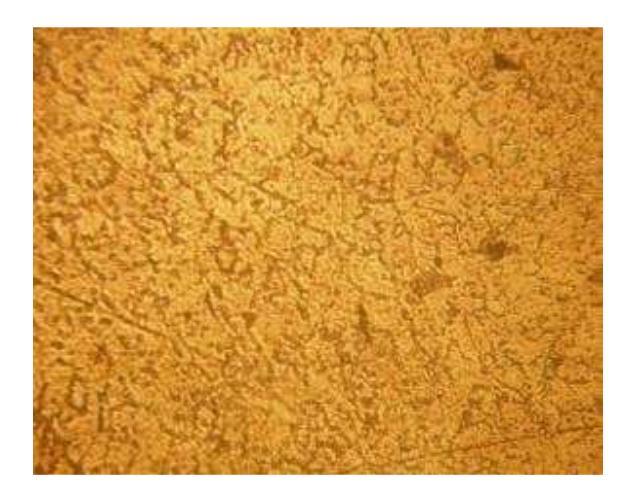
Figure 4. The micrograph shows at 400X the microstructure observed using in situ metallography in zone 1.

Figure 4 shows the in situ metallography microstructure of Zone 1, which corresponds to the laboratory microstructure of the Zone A. Evidence of carbide precipitation in the grain boundary can be seen, which delimitated very clear the grains, and no evidence of pearlite bands. In the micrograph it can be seen that the grains are elongated as in Figure 2.

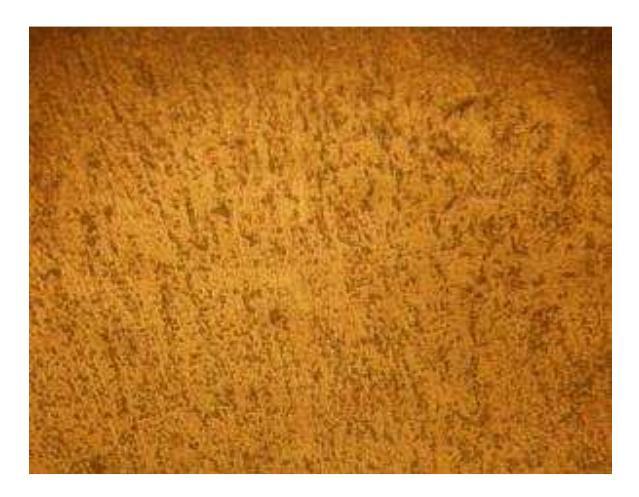
Figure 5. The micrograph shows at 400X the microstructure observed using in situ metallography in zone 2.

Figure 5 shows the in situ metallography microstructure of Zone 2, which corresponds to the laboratory microstructure of Zone B. It can be seen no evidence of carbide precipitation because no limited phases are delimited, therefore no elongated phases appear.

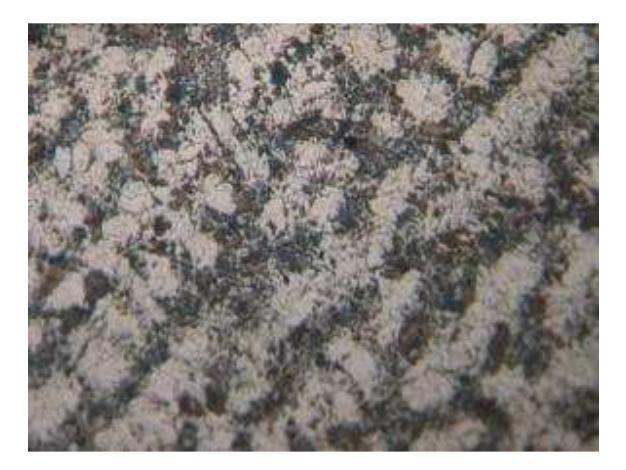
Figure 7. The micrograph shows a gray iron with E type graphite.

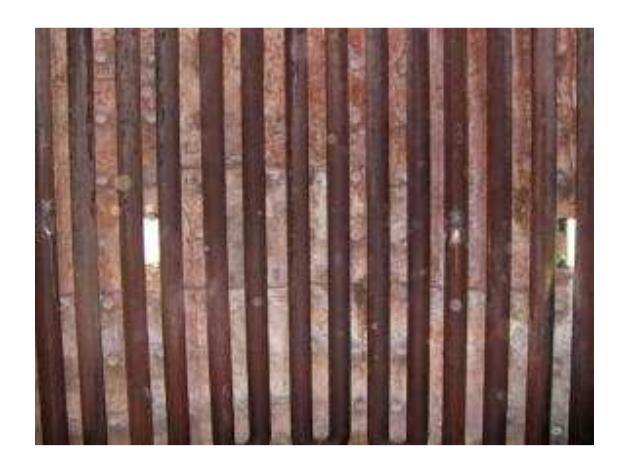
In Figure 8 boiler's tubes are shown. The boiler was out of operation for maintenance and in situ metallography. Figure 9 shows the result of the in situ metallography. The microstructure consisted of ferrite and pearlite; there was evidence of degradation of the microstructure.

Figure 8. Tubes of a boiler during maintenance.

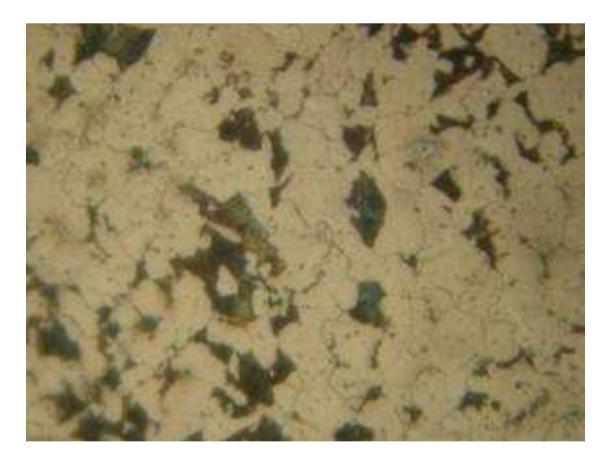
Figure 9. Microstructure of the Boiler's tubes.

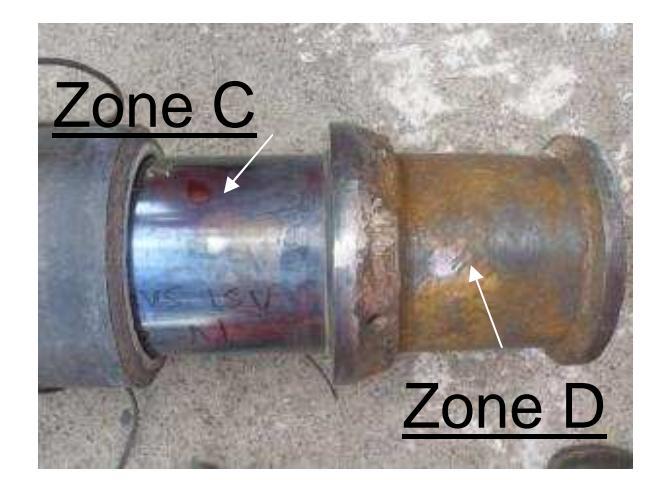
Figure 10. The image shows the zones (Zones C and D) where the in situ metallography was carried out in the equipment.

In this case, it can be seen that grains in Zone D are bigger than grains in Zone C, indicated grain growth in Zone D, where heating had taken place. The grain growth was found in a qualitative way by comparing the microstructure at the same magnifications. However, no evidence of sigma phase precipitation was found. One example of a damaged microstructure by sigma phase precipitation is shown in Figure 13. The equipment shown in Figure 13 failed suddenly after 15 years of service and the operation had to be stopped for repairing. This stop might have been avoided if in situ metallography had been carried out during maintenance.

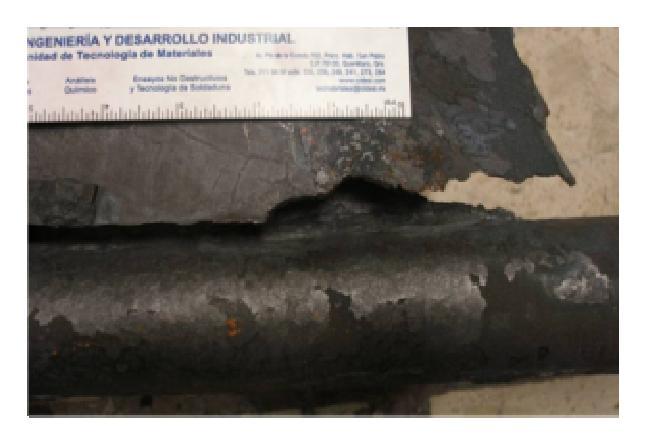
Figure 13. The image shows a damaged equipment.

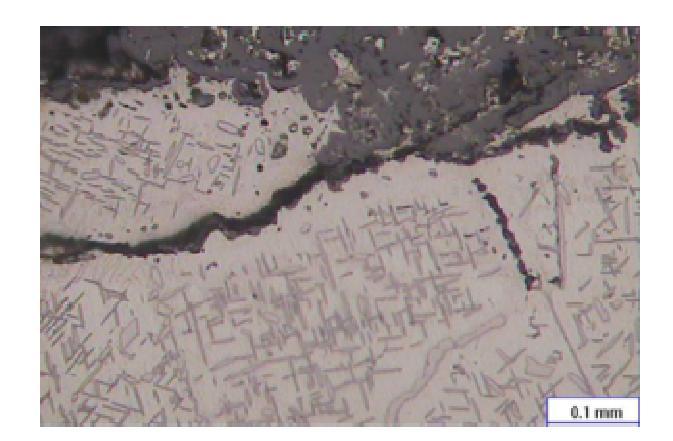
Figure 14. The image shows the microstructure of the equipment shown in Figure 13. It can be seen sigma phase precipitation.

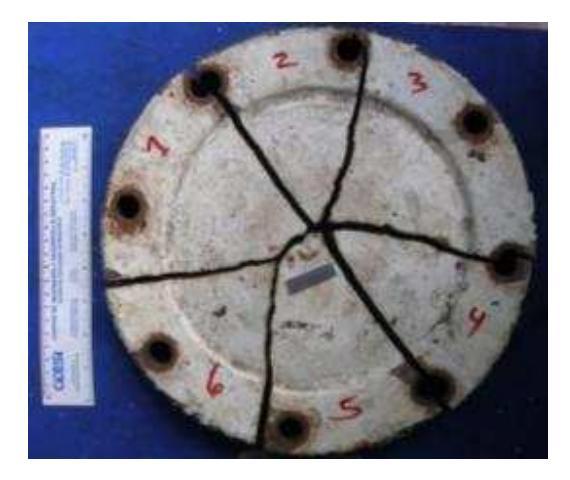
A valve's cover had failed in a sudden way. As first approximation in situ metallography was carried out in order to find if the material of the valve's cover was correct.

Figure 13. The image shows the failed valve's cover.

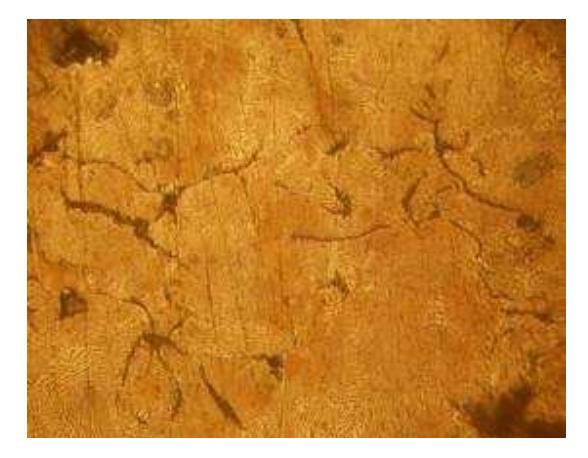
Figure 14. The micrograph shows the microstructure of the failed component, which consisted of gray iron.

Using in situ metallography the microstructure of the gray iron was revealed and it consisted of graphite flakes and a matrix of pearlite, but also was found evidence of a bright phase. Using other experimental techniques it was discovered that this bright phase consisted of steadite (Fe₃P).
