Buell 1125CR Charging System Overhaul

This writeup covers the charging system work I did on my 2009 Buell 1125CR. It should apply to any 2009 or 2010 Buell 1125 motorcycle. This writeup is provided for informational purposes only; I accept no responsibility for the results of applying this information.

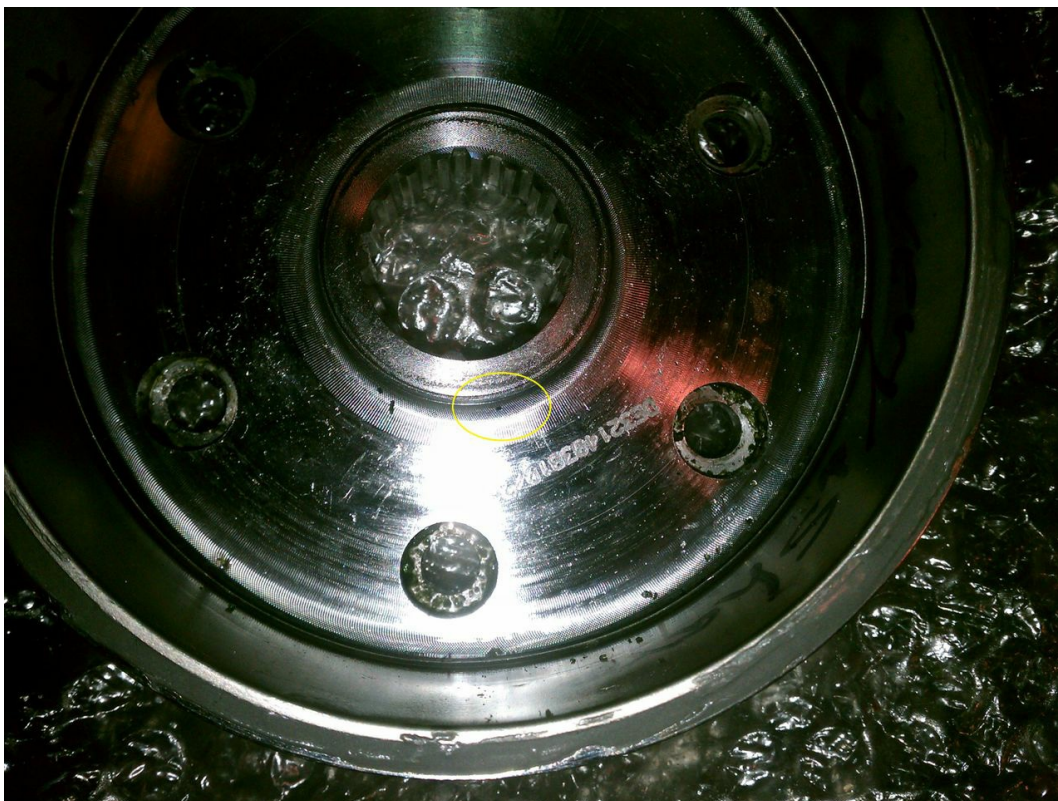
If you look carefully at the photo of the rotor above, you can see the tiny oil spraying hole in the area circled in yellow. It looks tiny, but it doesn't take a very big hole to spray enough oil to cool things down.

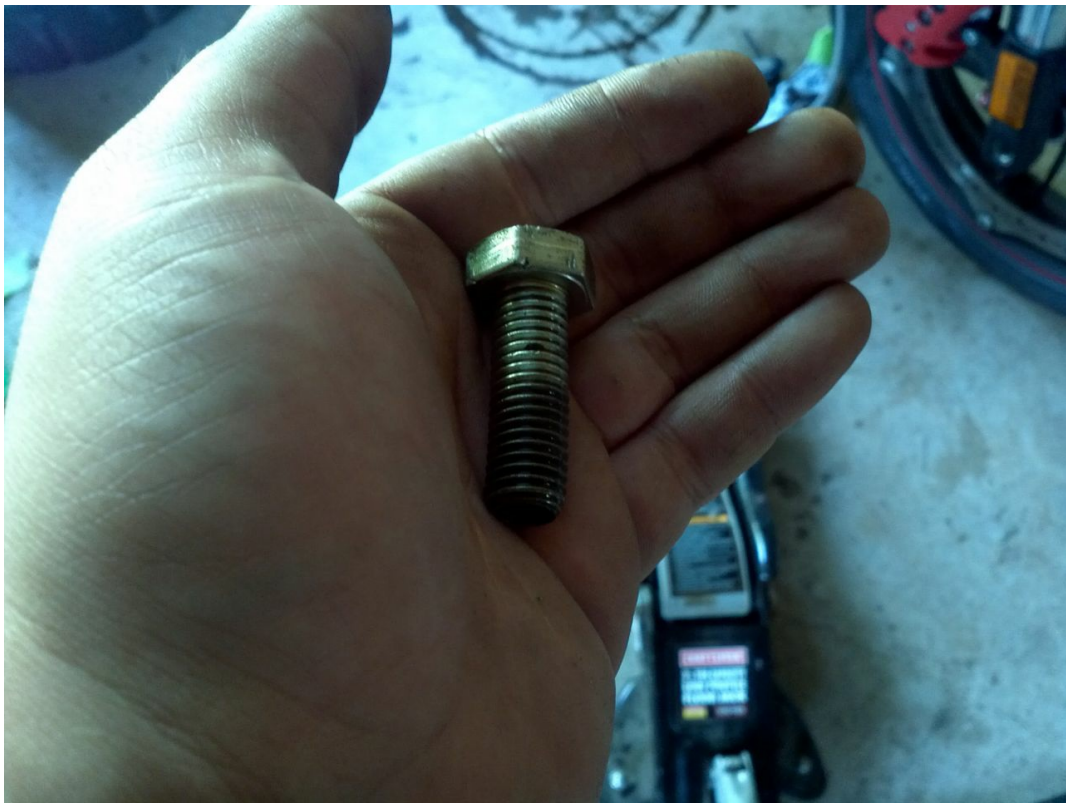
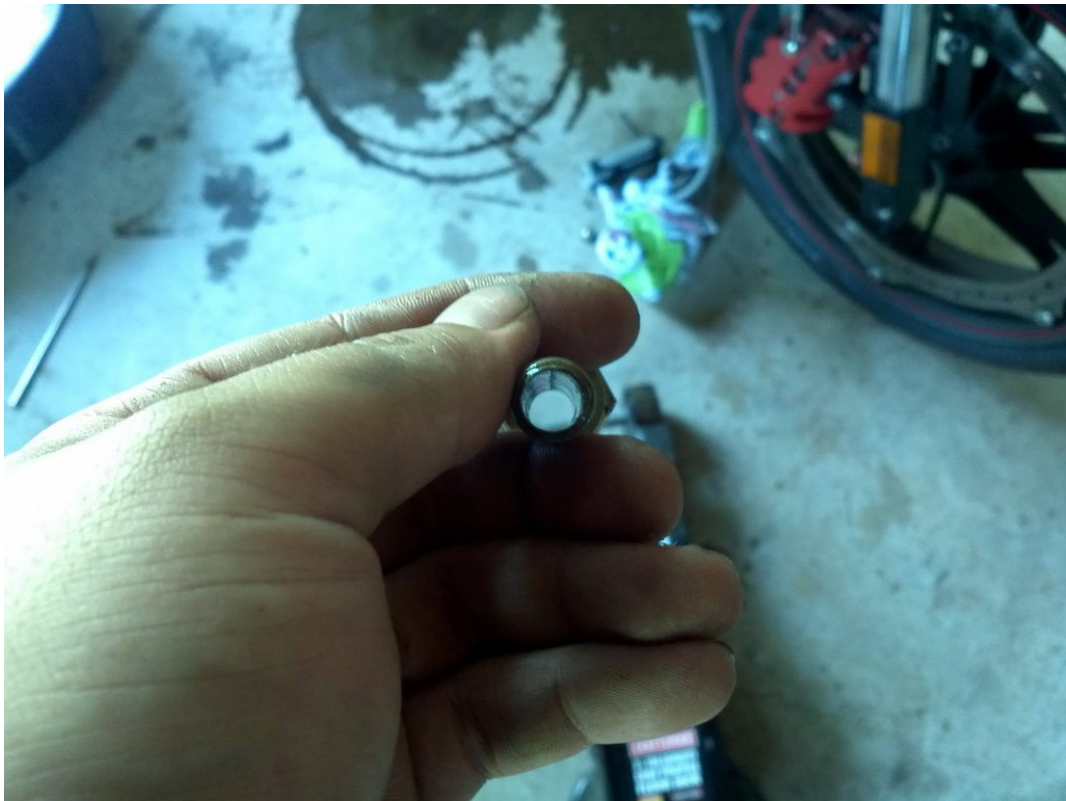
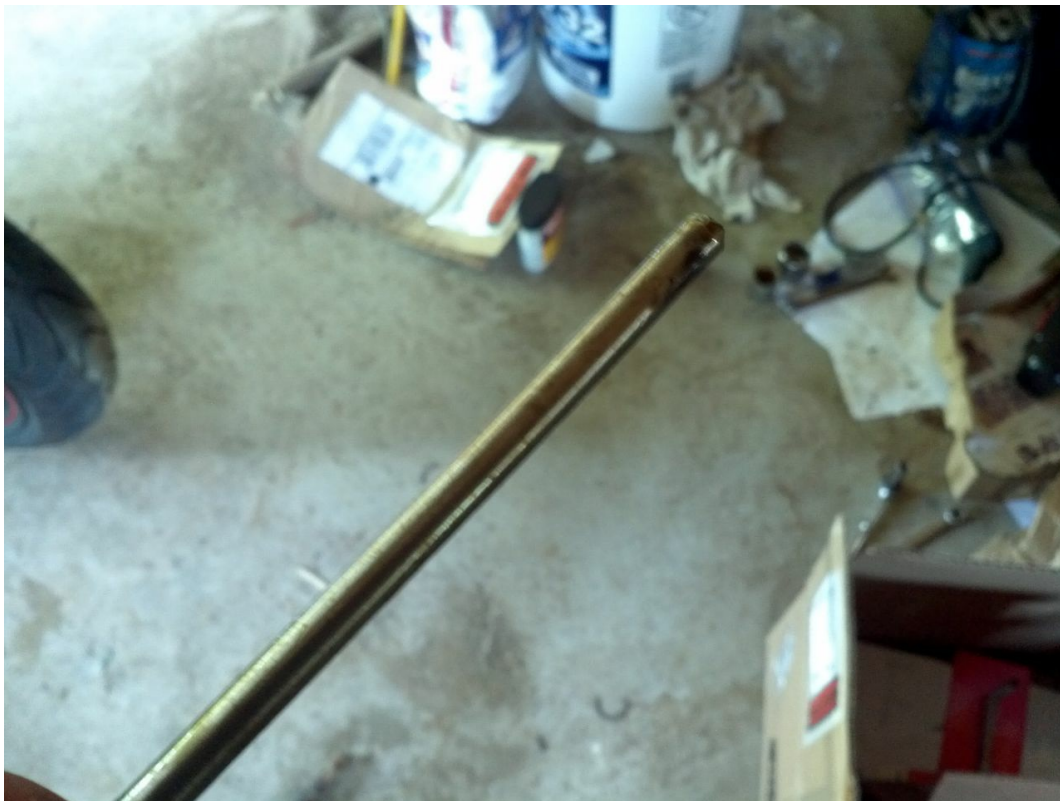
I drilled out an appropriately sized bolt (to protect the threads in the engine casing), and used an appropriately sized hardened steel rod.

I was able to get the crankshaft locked with the tool, however, the tool slipped out of the hole with only around 50 ft-lbs of torque applied. Rotor nut installation requires 295 ft-lbs, so this was nowhere near enough! *Note: I wouldn't recommend attempting to DIY this tool, unless you or someone you know is skilled in toolmaking. I've read reports of others not faring as lucky as I did, and having the tool break off rather than slip. If you have something break off in the crankshaft, it **will** ruin your day!*

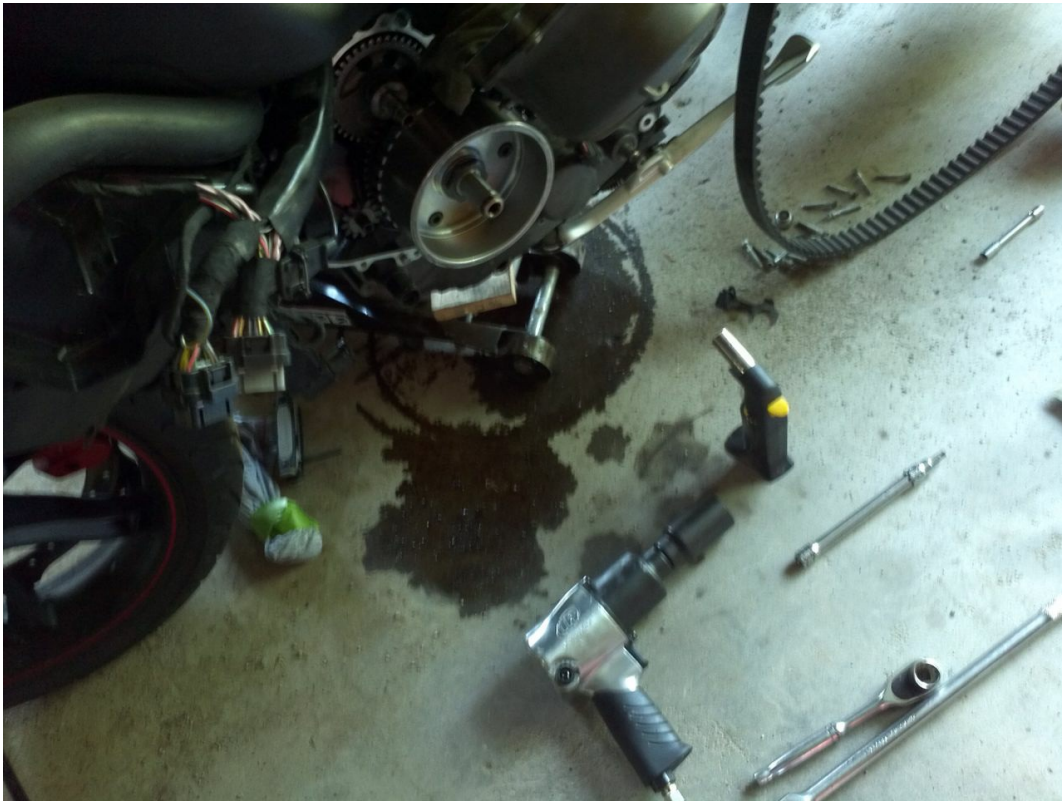
Once the splines are lined up properly, the new rotor slides right on the crankshaft. I cleaned up the crankshaft threads with brake cleaner, and applied threadlocker, and loosely put the nut on. The recommended torquing procedure is to tighten to 210 ft-lbs, back the nut off 2 full turns, then tighten to 295 ft-lbs. This is to get the thread locker activated and such. I had to improvise here, so I lightly torqued the nut on with the impact, backed it off a couple of turns, then tightened it on. Since my impact was rated for 300 ft-lbs, I let it work nut on for a couple seconds.

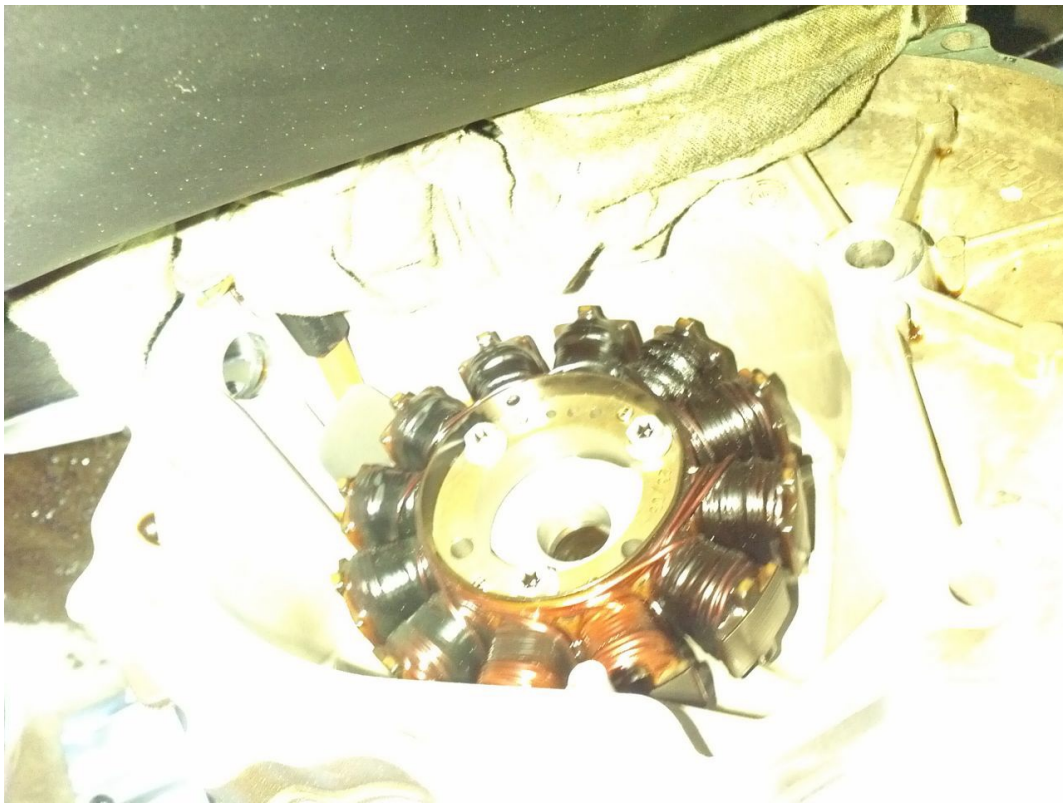
Unfortunately, when installing the new rotor, I could tell that my stator was almost toast. It had the tell-tale burnt epoxy and looked in bad shape. So, I began investigating options for a new stator.

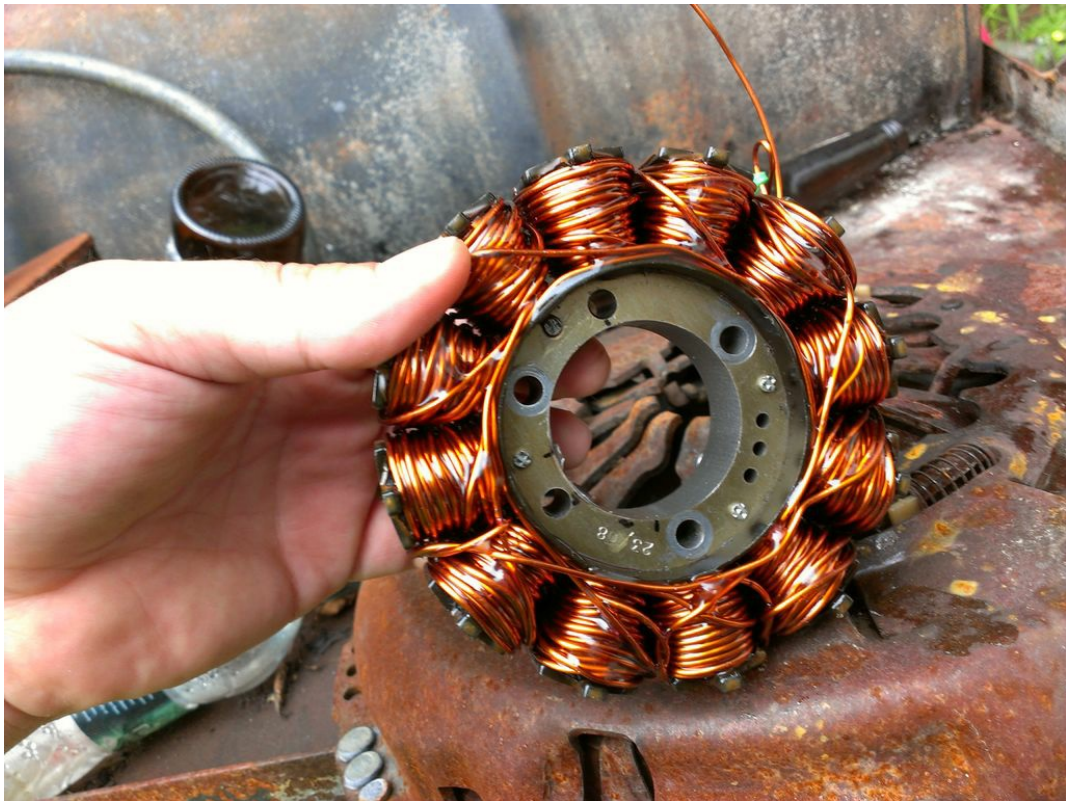
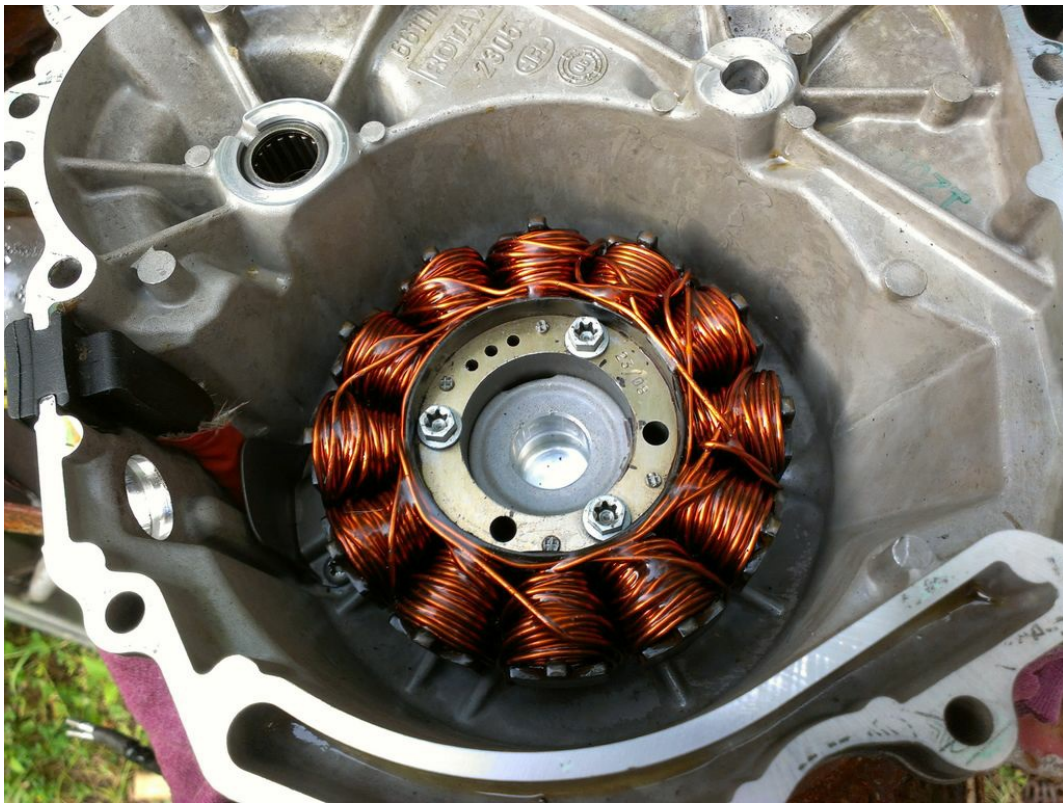
My first rewind stator failed. This was due to my windings being messy. I'm almost embarrassed to show pictures...

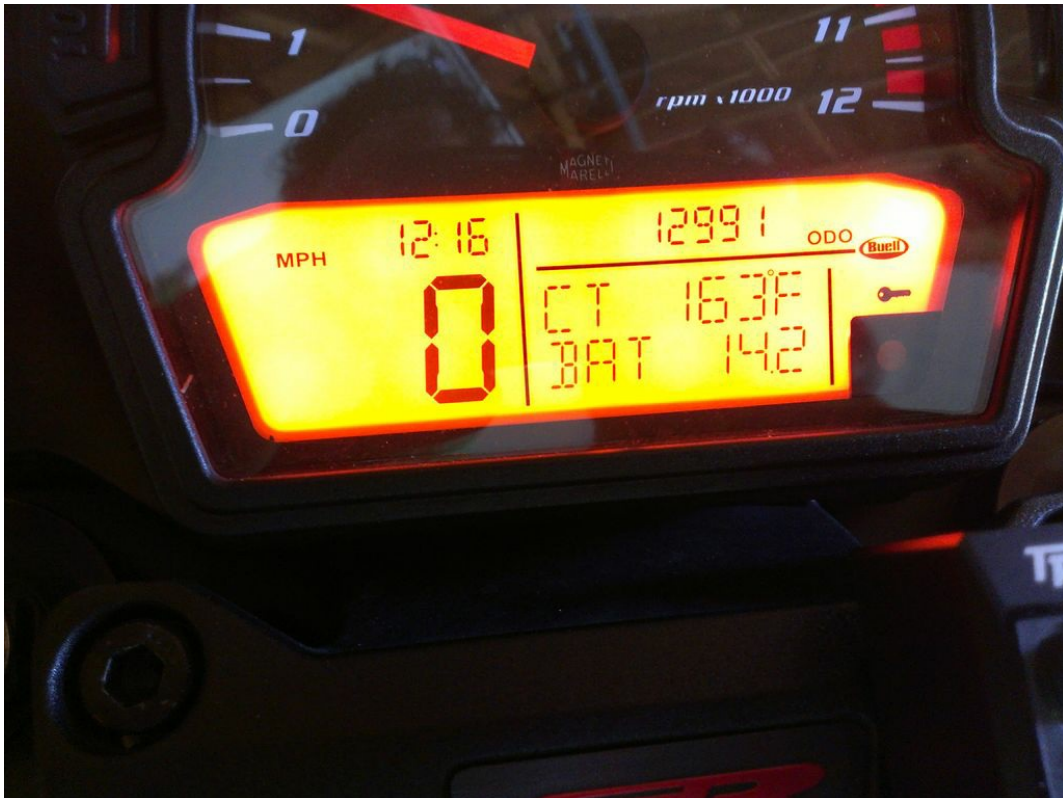
I got everything buttoned up, and on the stock regulator, voltage output was fine.

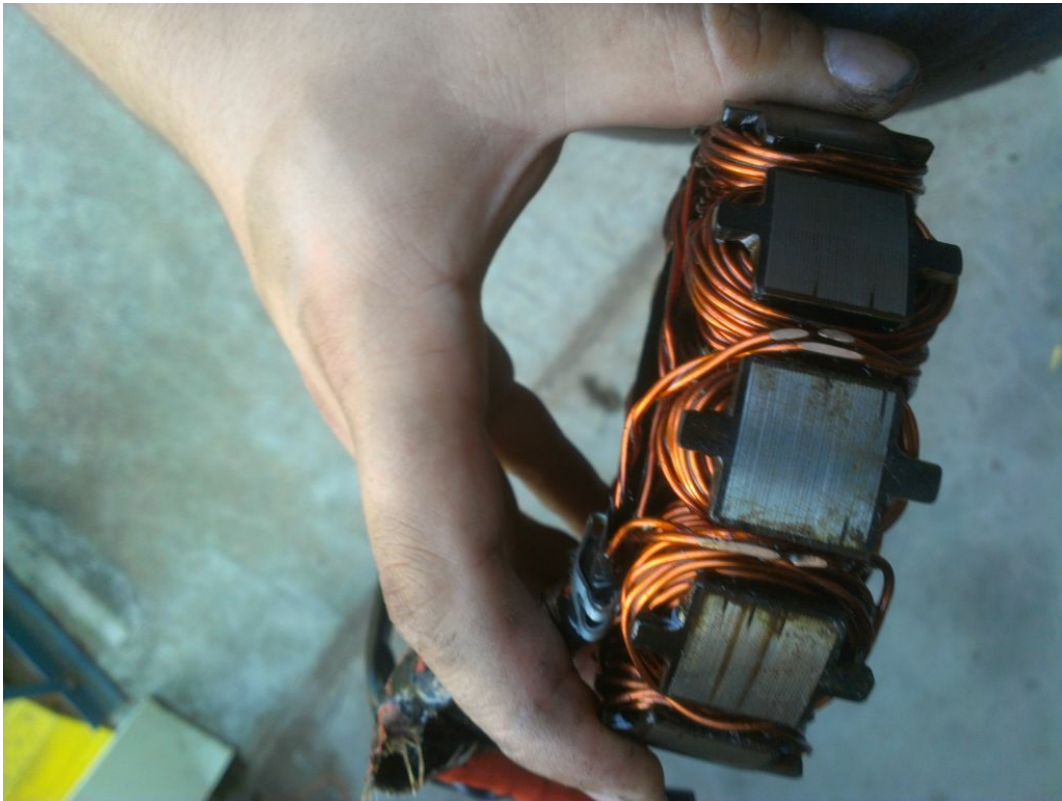
I took the stator out, and immediately saw why it failed:

The windings were too messy, and some made contact with the rotor, and eventually rubbed through. Unfortunately, this took a toll on my new rotor as well. Rotor is still working fine, it just looks ugly. Next time I have the motor apart for a valve check/adjustment, I'm going to fill in the damaged section with epoxy.

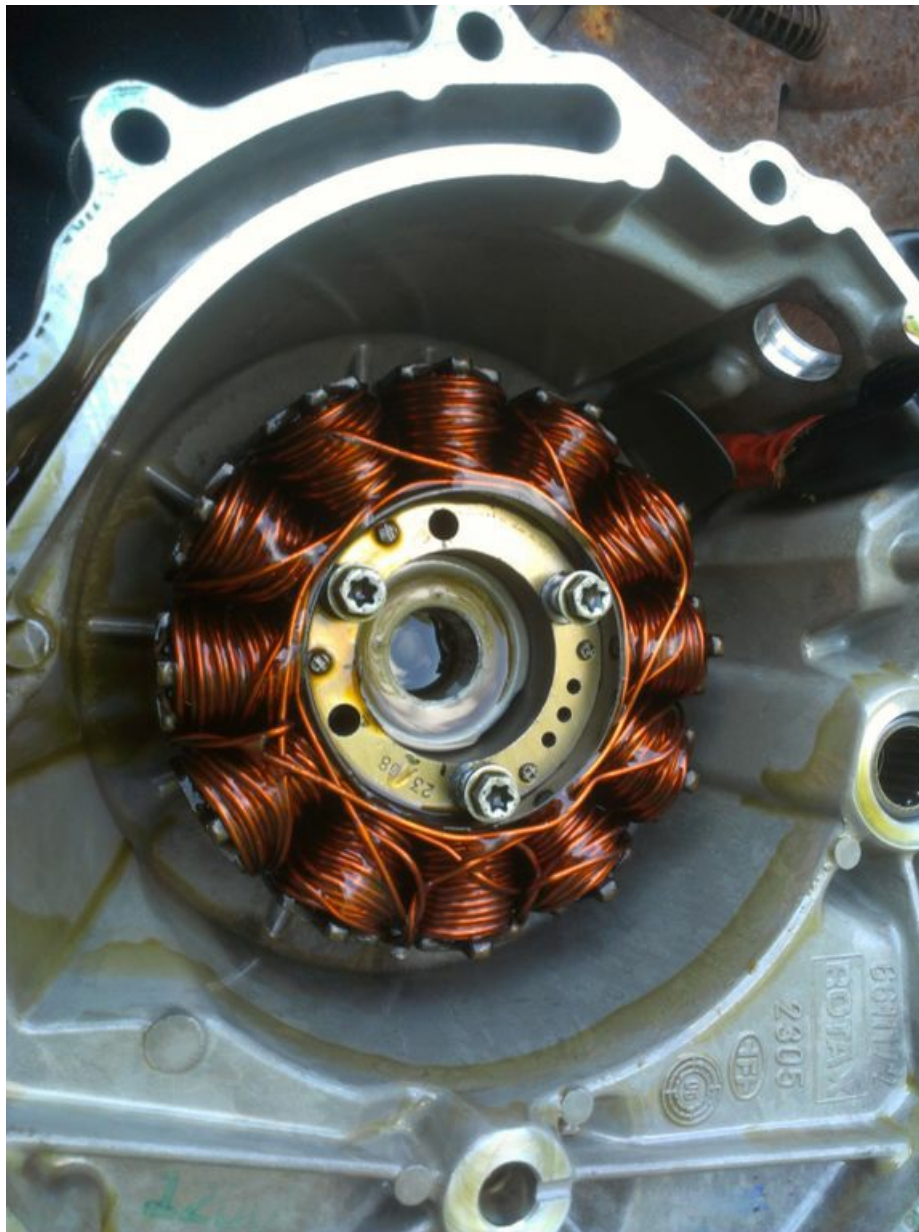
The stator lasted several thousand miles before failing, and almost all of that time was spent on the stock, shunt regulator (I'll discuss this in the regulator section, but shunt regulators short the stator out to bring it down to the regulated voltage, so stator is always running at maximum output). The stator, aside from the damage, still looked brand new, so I'm confident in the wire and epoxy choice:

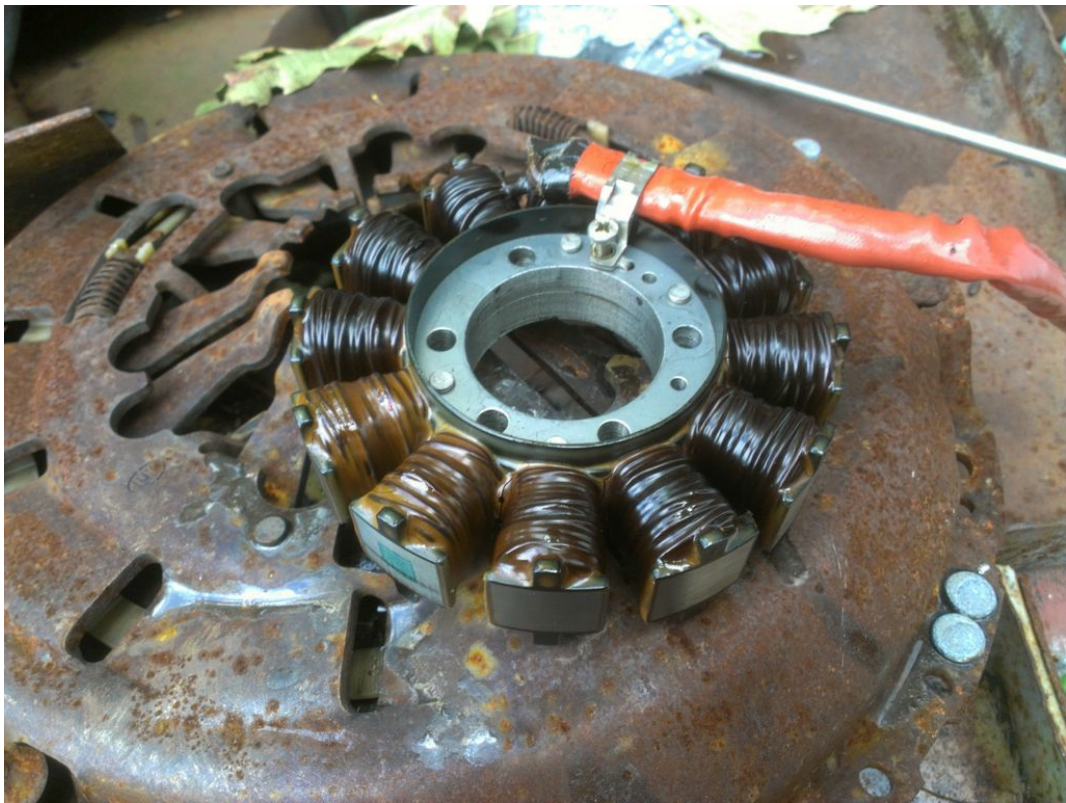
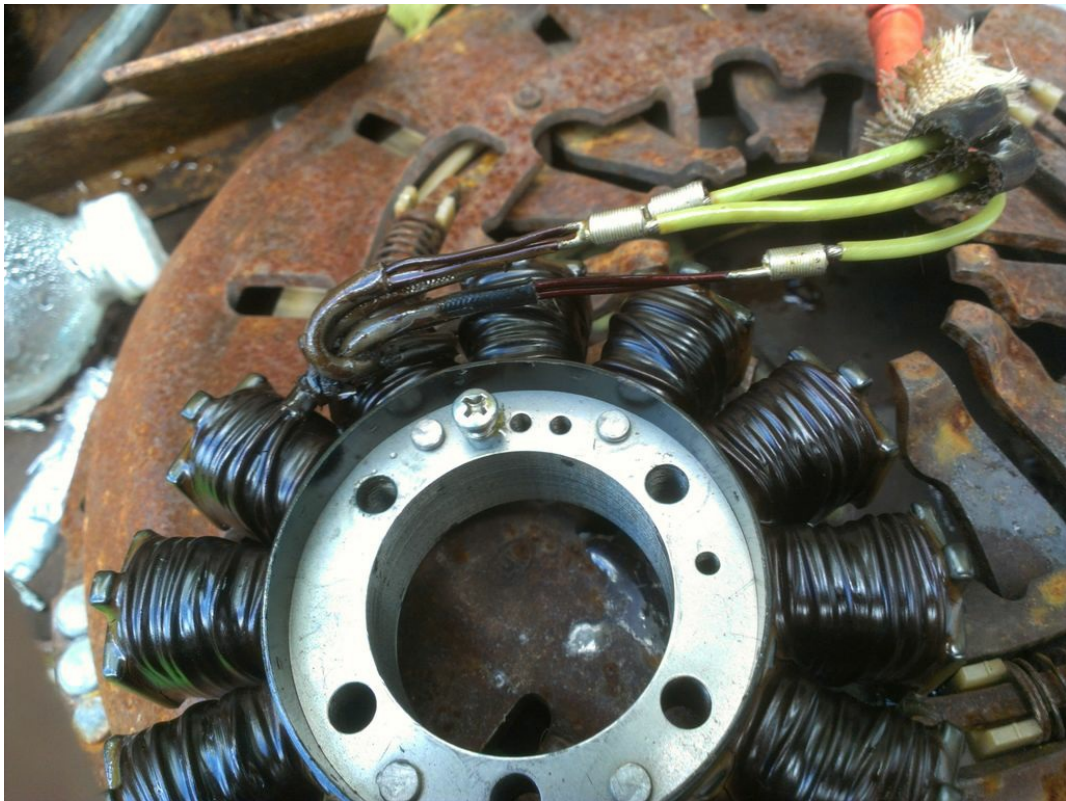
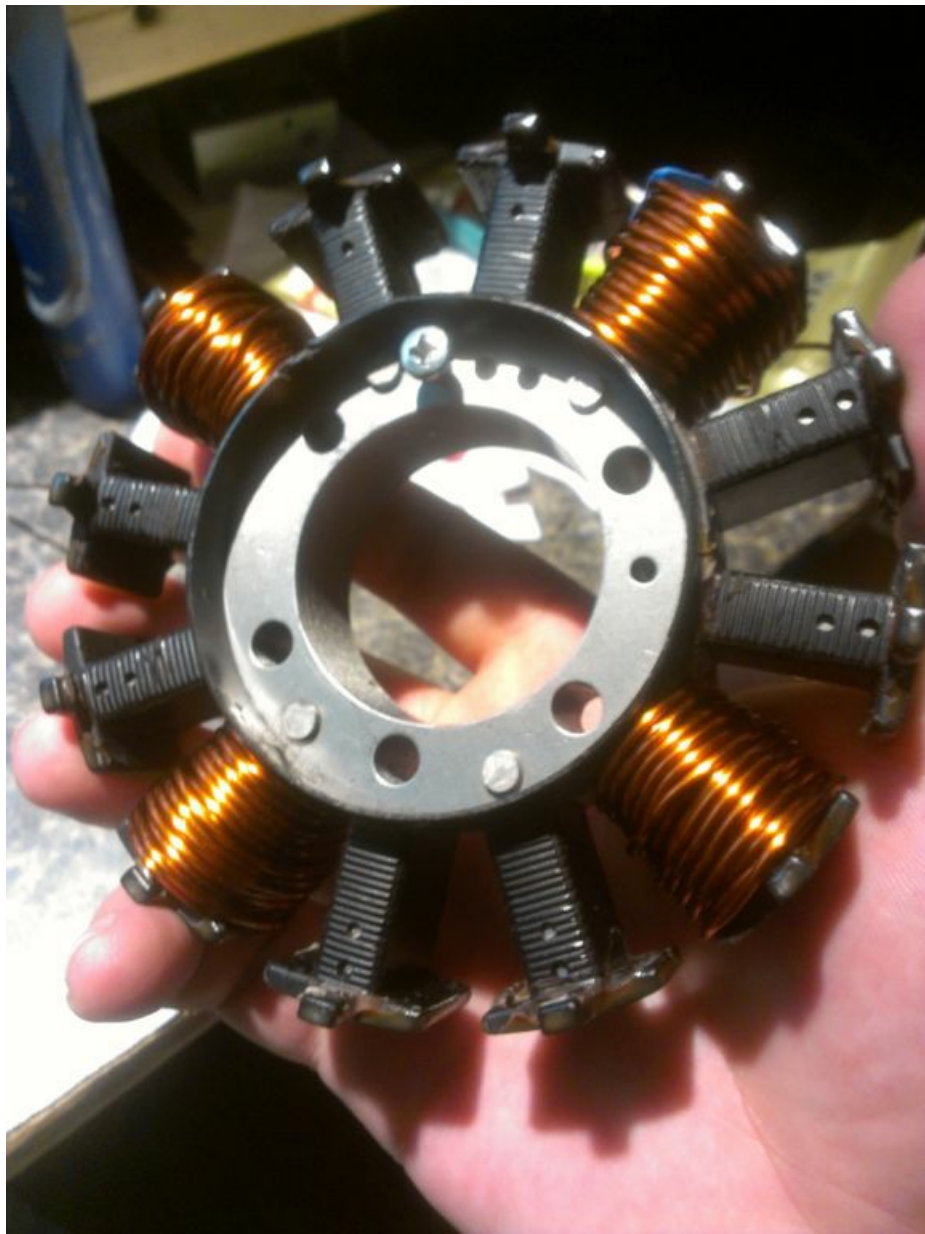
I rewound another failed stator core, this time taking more care in keeping the windings neat and compact. It's still not as good as Hildstrom's job, but it did come out *much* neater. I'm happy with the result.

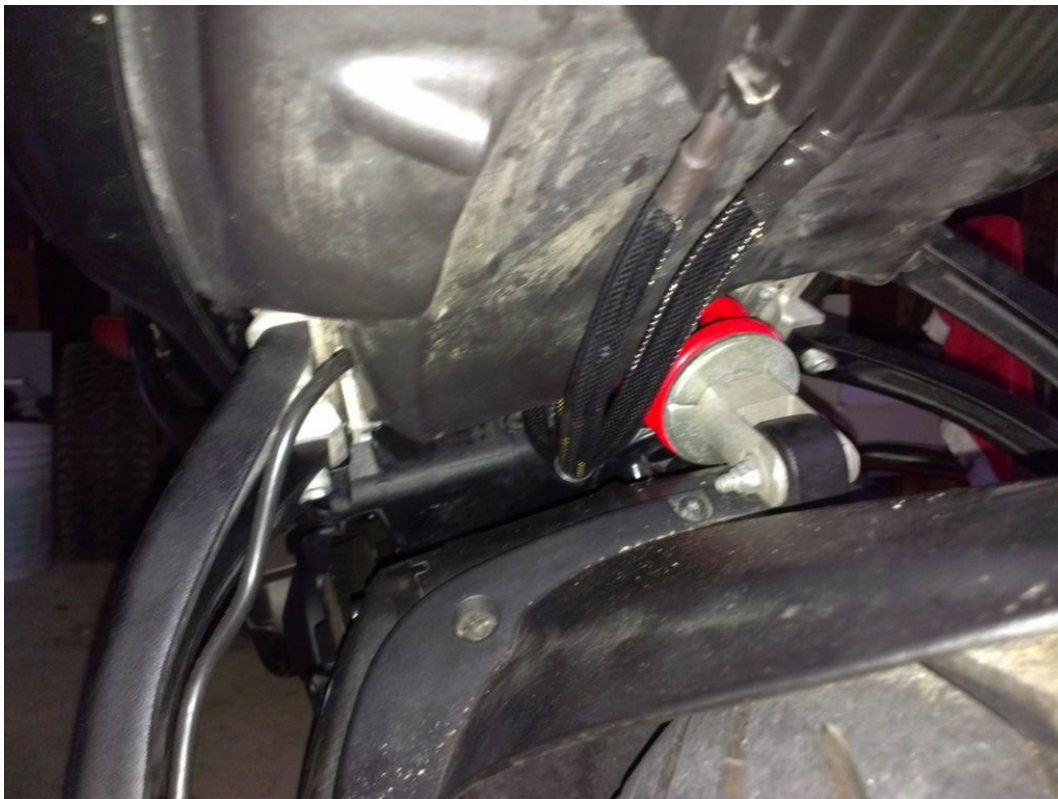
I mounted the regulator underneath the tail section. The instructions tell you to keep it out in direct airflow, however this is the best place I had for attaching it, and have not had any issues with the regulator staying cool.

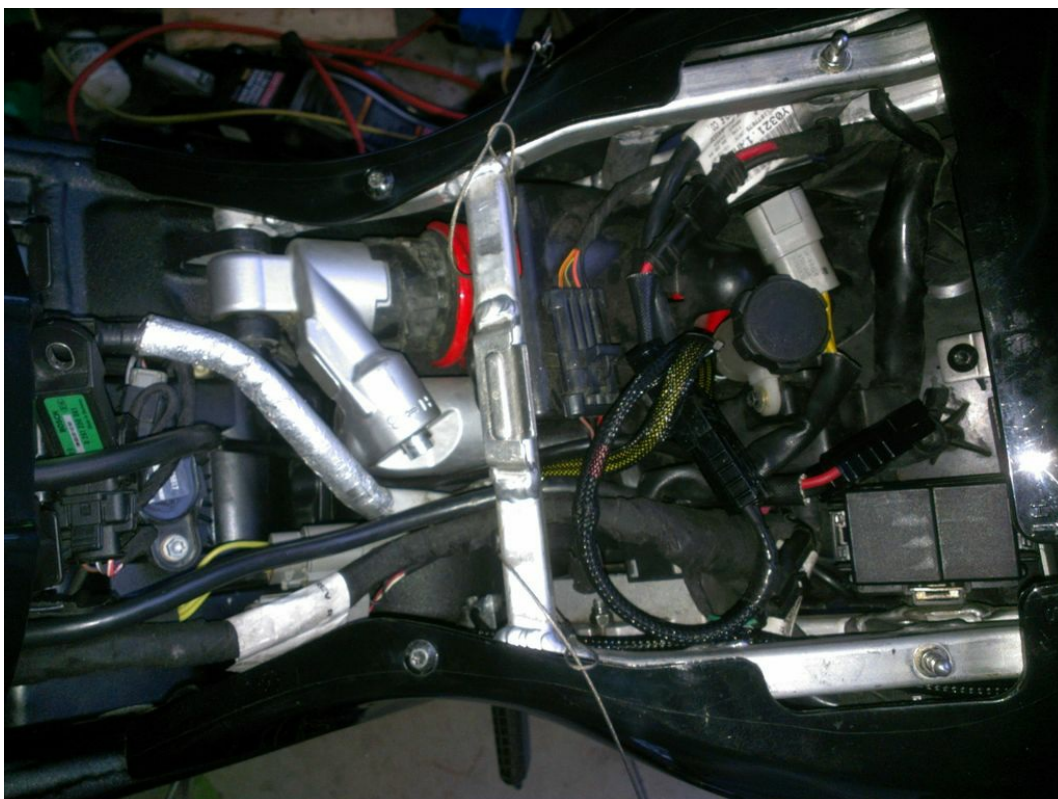
I used a new Deutsch connector to mate with the stator connector, so as to leave the stock regulator in place. I needed to cut the harness off the stock regulator, as it is a non-standard connector, and I did not want to cut the harness on the bike. I then put an Anderson SB50 connector on the harness, the leads from the CE-605SB, and on the leads from the stock regulator. This allows me to swap back to the stock regulator by swapping the two connectors, so if something happens to the new regulator, I won't be stranded.

The instructions do tell you to wire the regulator straight to the battery. However, I'd rather not route all of the electrical demands of the bike through the battery fuse in the long run. I chose to hook it into the harness where the stock regulator hooked in, to preserve the original electrical design. There's no issue with the wiring harness, so I saw no need to bypass it.
