# Common Codes and Corrections for the Allison LCT 1000

by Steve Garrett

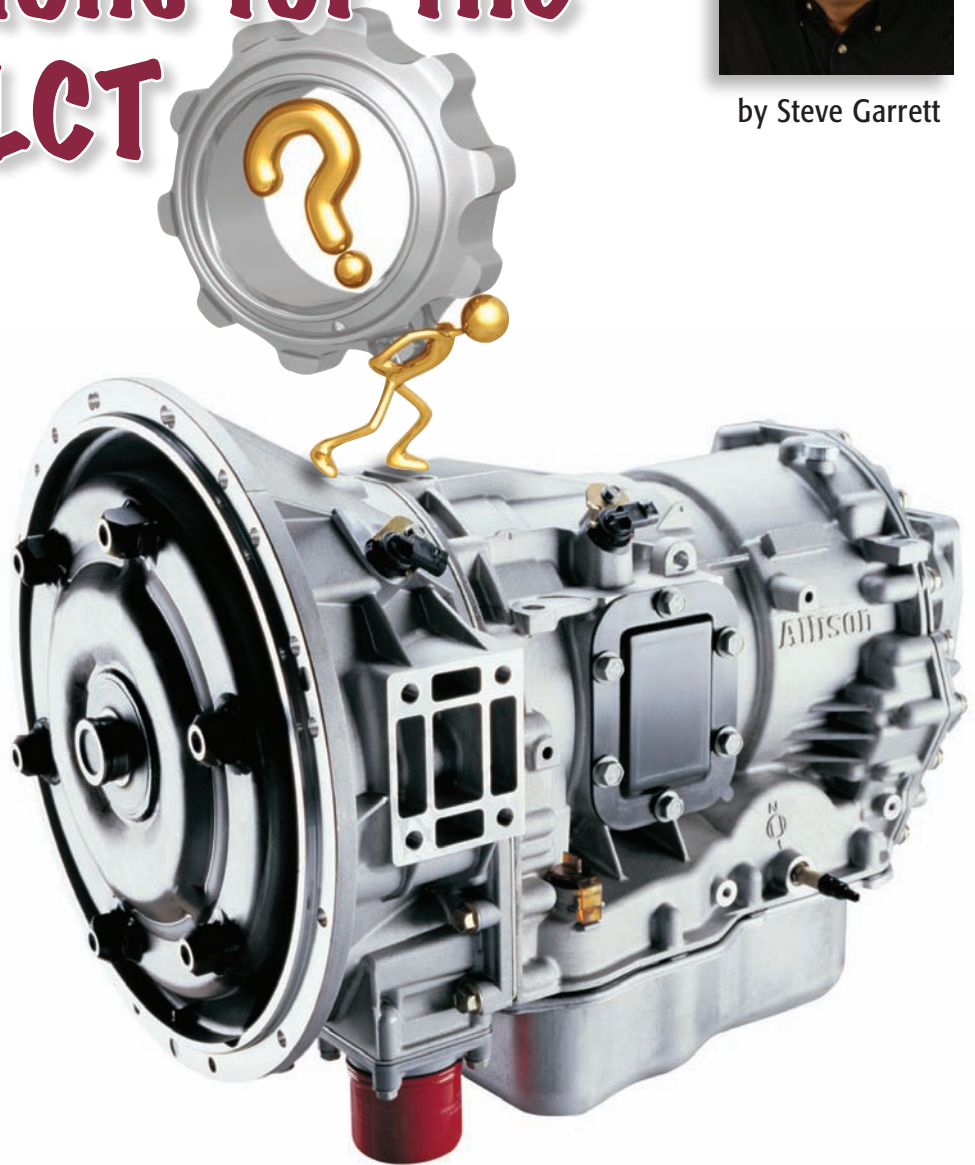
- Inspect for a sticking or damaged main regulator valve.
- Inspect for a sticking or damaged lube regulator valve (figure 1). An updated valve kit is available for earlier applications under GM part number 88996718. This kit is designed to reduce the chance of air
