Service Bulletin

Bulletin No.: 20-NA-012

Subject: Radio Software Version V135116 Over-the-Air Update

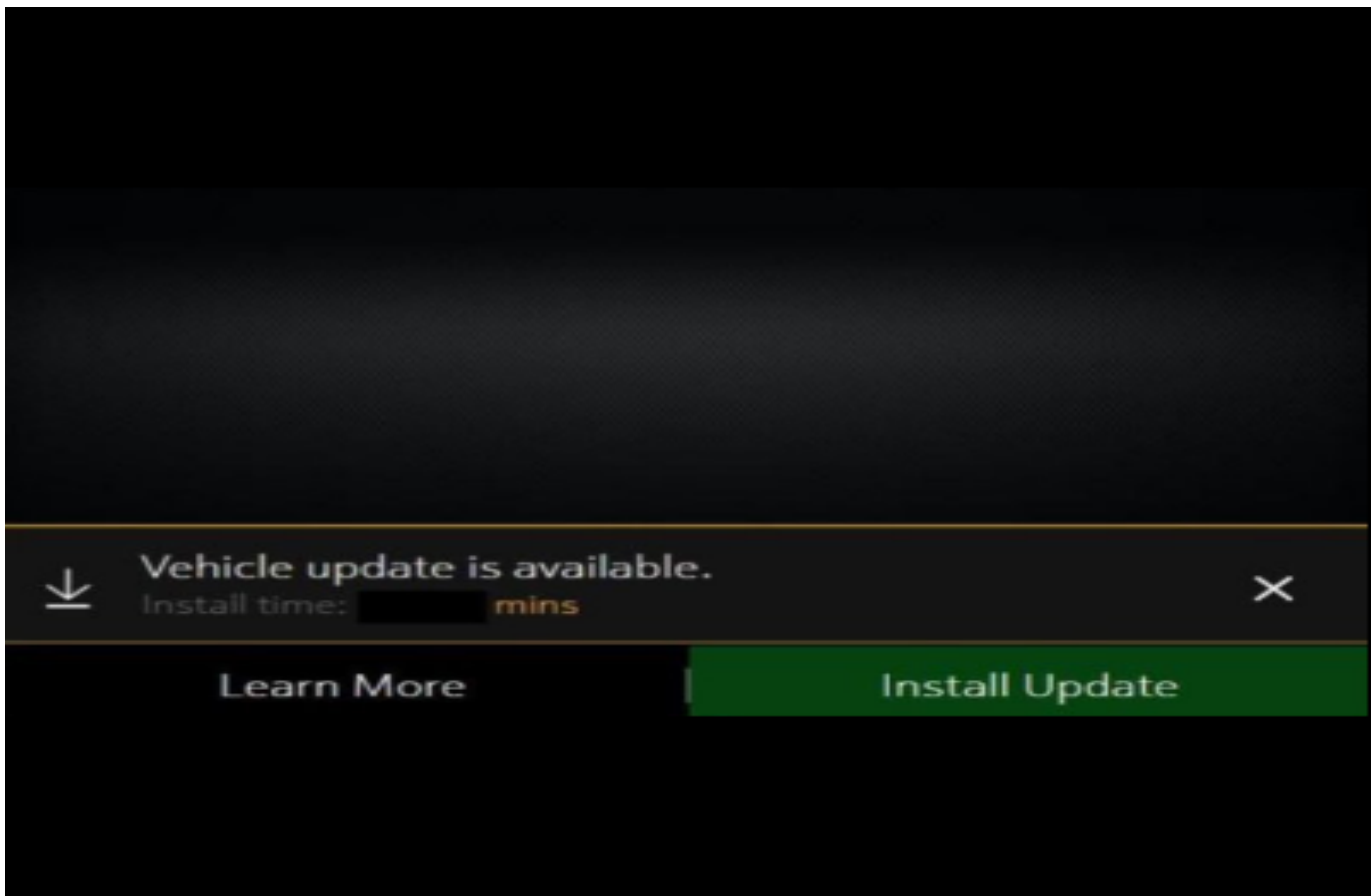
5494687

1. If a remote package is on the system, you may see the below pop up upon shifting the vehicle to Park.

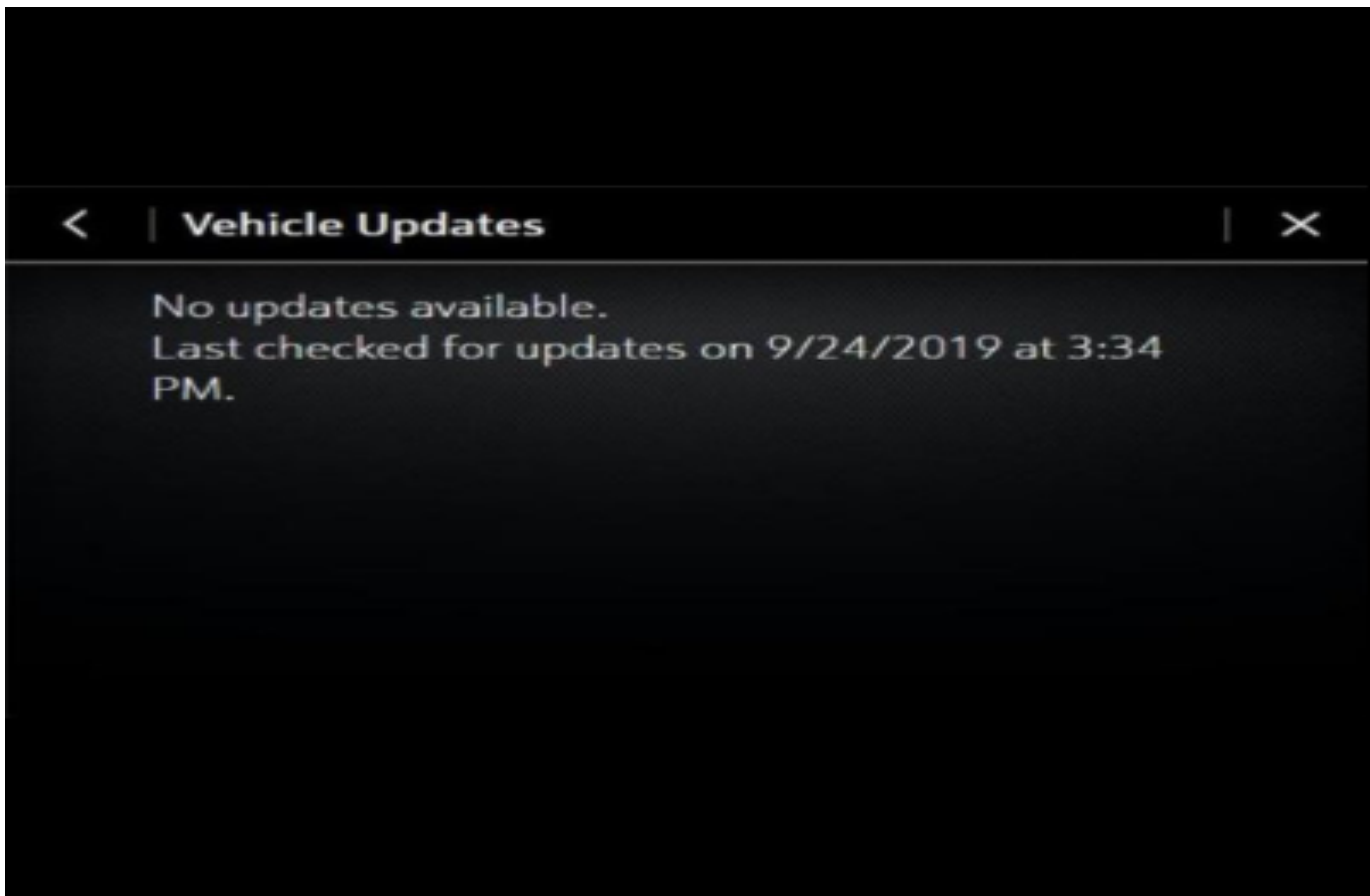
5495353

2. Select "Install Update."
 - If no update available pop up is displayed, navigate to "Settings" -> "Updates." If there is a remote package downloaded on the system, it will display "Install Now", proceed with install. If there are no options available, proceed with the software update following the **Update Procedure Using TIS2WEB (USB Download)** section of this document.

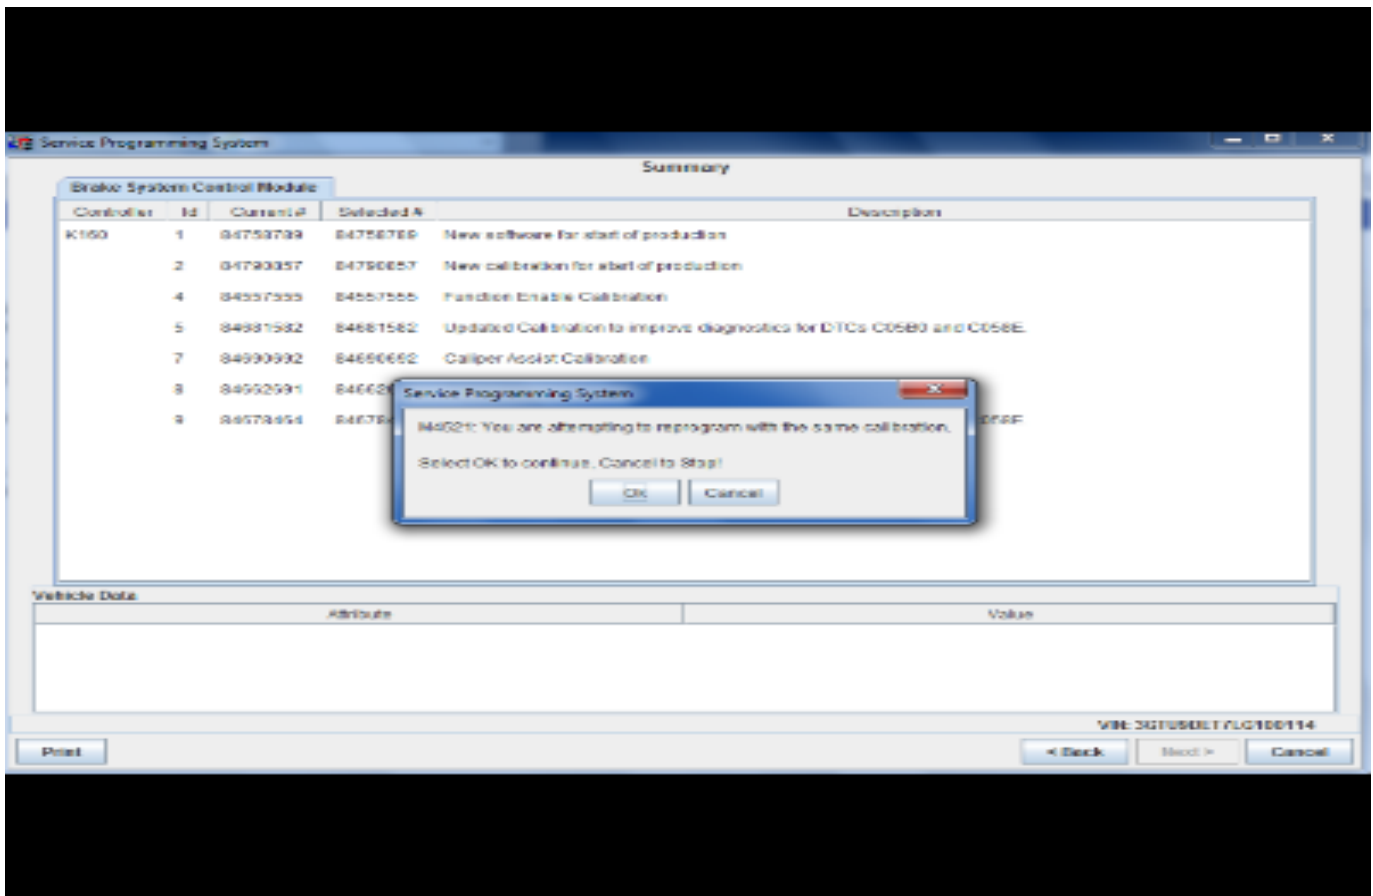
5431207

- During the programming procedure, follow the SPS prompts for the correct ignition switch position.
- Refer to Radio Programming and Setup for additional information on programming.
