Techstream ECU Flash Reprogramming Procedure

Service Category Engine/Hybrid System

Section Engine Control

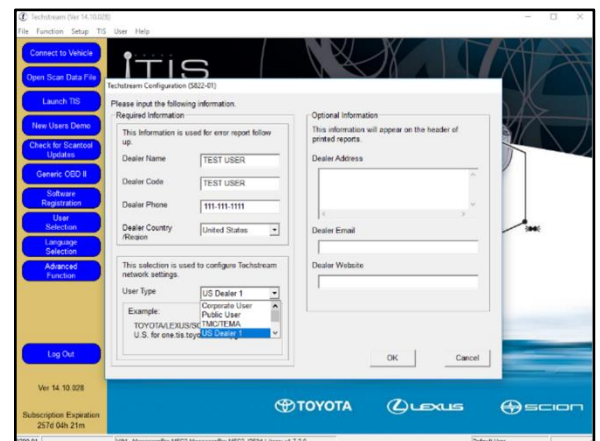
Figure 1.

1. Select Setup from the Techstream main menu screen.
2. Select Techstream Configuration from the Setup dropdown menu.
3. Select the area and language.
4. Input information and select US Dealer 1 from the dropdown menu.

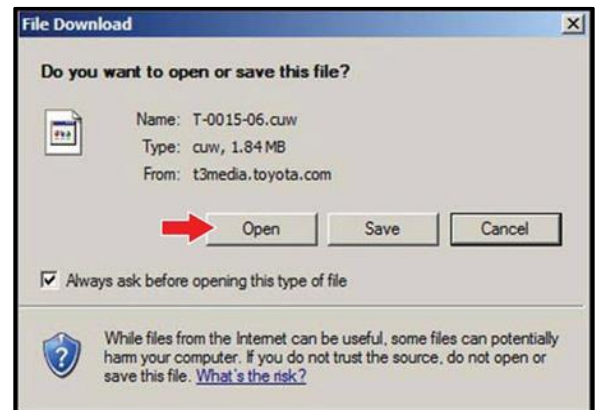
Figure 11.

- B. Click Open to load the calibration file information.

Techstream downloads calibration files as needed to ensure the latest calibration file is used. Do NOT save calibrations locally on the hard drive or other media.

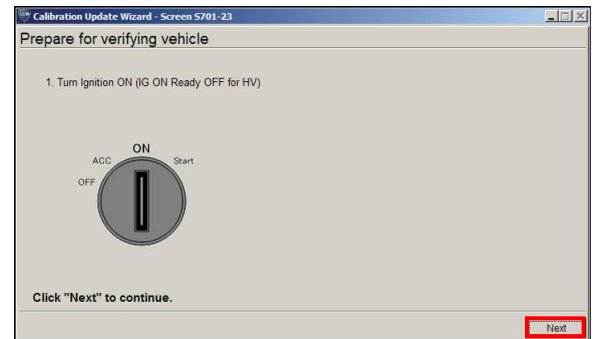
Figure 22.

- L. Turn the ignition to the ON position, then click Next.
