SIMMONS-EDWARDS HOUSE
(Pineapple Gate House)
12 & 14 Legare Street
Charleston
Charleston County
South Carolina

WRITTEN HISTORICAL AND DESCRIPTIVE DATA

HISTORIC AMERICAN LANDSCAPES SURVEY

HALS NO. SC-11

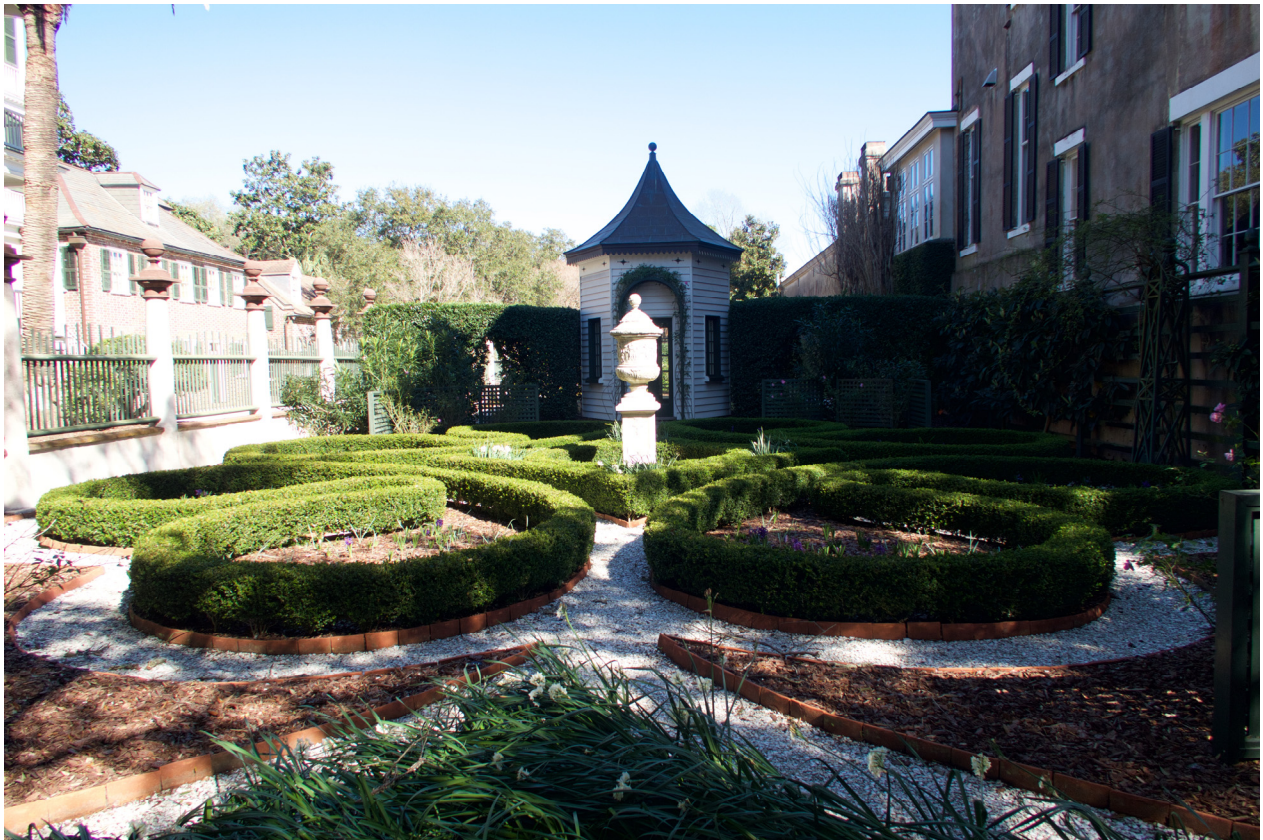
View from the street, looking east into the front or spring garden. The oyster shell paths, sculpted boxwoods, carved sculpture, garden folly, trellises, and separation fence are visible in the photograph. (Clayton Johnson, February 26, 2016)

The front or spring garden was originally intended to be visible from the street as well as from the piazza during social gatherings. Small boxwoods are sculpted into rosary and lozenge patterns and are bordered by oyster shell pathways. A variety of trellis styles at differing heights are positioned around the center design. A garden folly building is located at the back of the first garden.

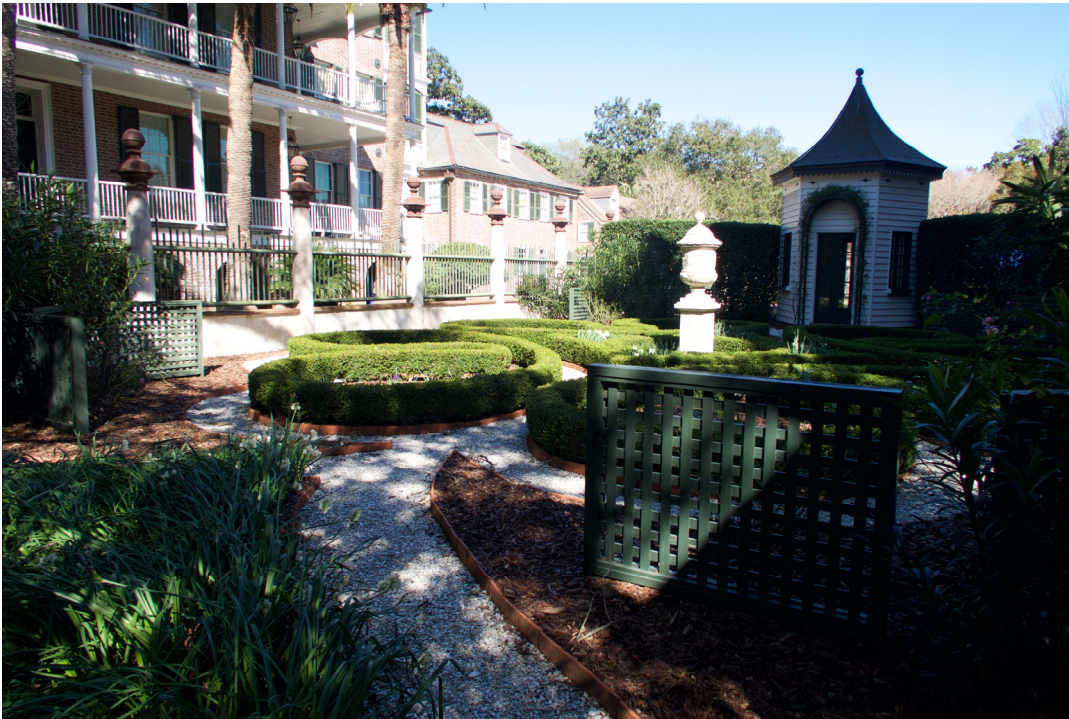
View from the southwest corner of the front or spring garden, looking northeast. The oyster shell paths, sculpted boxwoods, carved sculpture, garden folly, trellises, and separation fence are visible in the photograph. (Clayton Johnson, February 26, 2016)

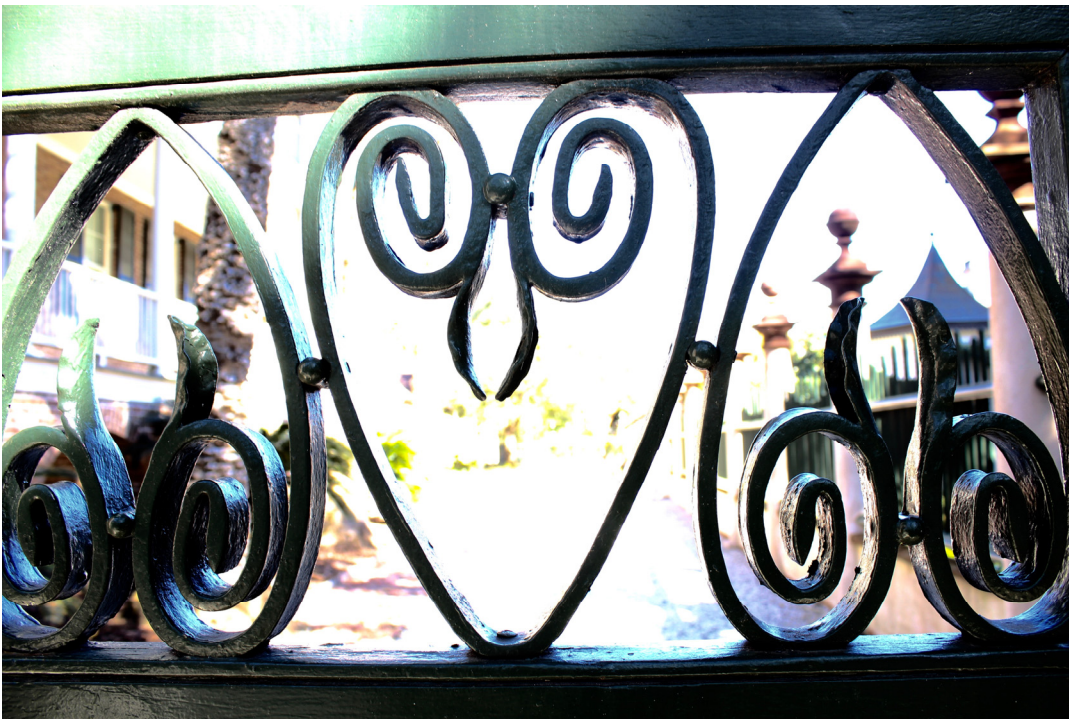
View looking east at the ironwork gates fronting Legare Street. (Jesse Cantrell, February 26, 2016)

Description: 14 Legare is a three-story Federal style house built circa 1818 with a raised basement and features a two-story piazza located on the south side of the house. The house yard and front garden are separated from Legare Street by wrought ironwork fencing with stuccoed brick columns topped with sandstone finials. Laid out in the same manner as the house lots of other larger Charleston houses, the deep lot of the Simmons-Edwards House pushed service function to the rear of the lot. At 14 Legare, a kitchen/quarter building (now attached to the main house by a masonry hyphen), a carriage house, privy and cattle shed lined two sides of a work yard. A paved carriage way, lined with a fence run between Tuscan columns, ran from the street to the work yard. The classically-ornamented fence separated the carriage way from the ornamental gardens.
